Local Flood Analysis

Hamlets of Shandaken and Allaben

Ulster County, New York

November 2017

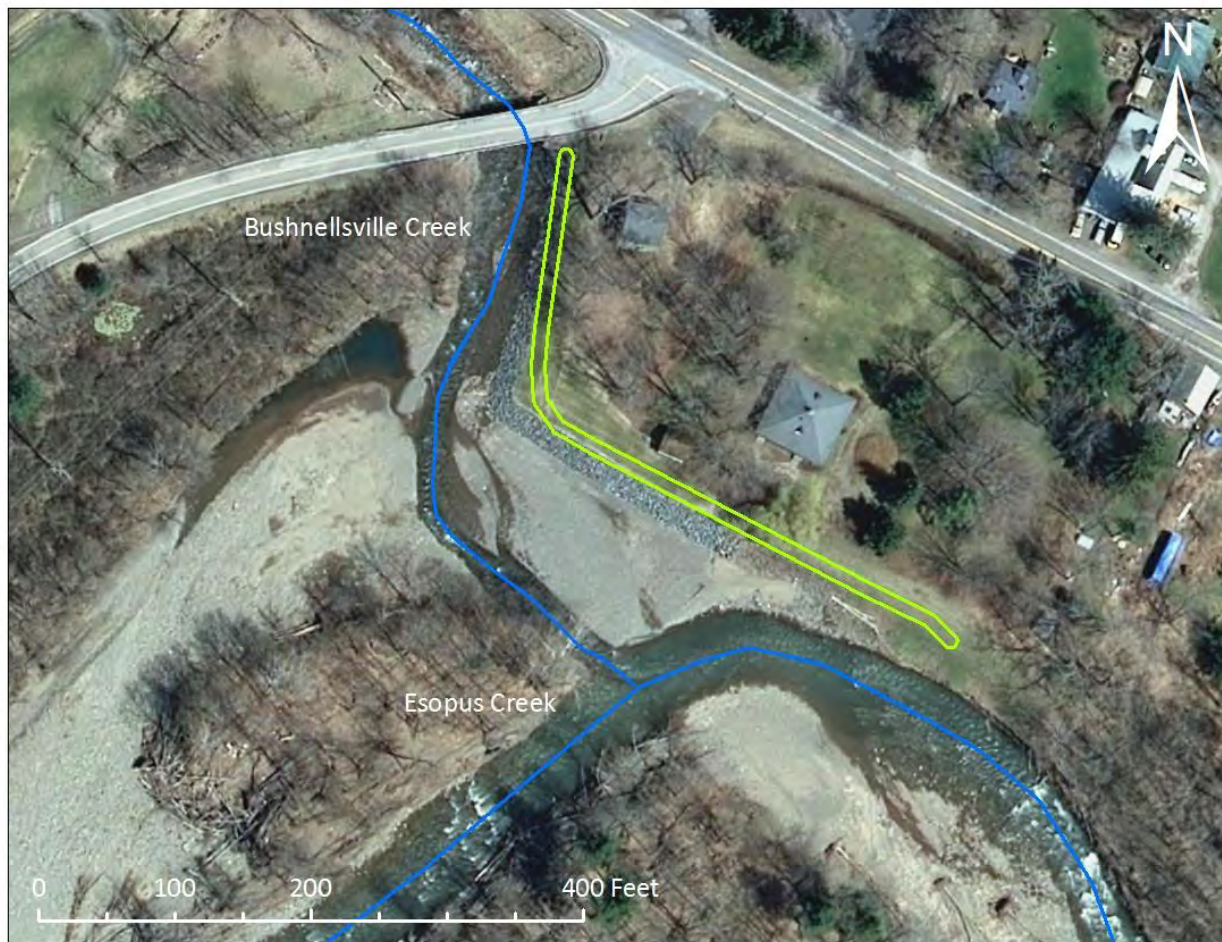
Figure 2-7

In the hamlet of Shandaken, a flood control levee lines the left bank of the Bushnellsville Creek and Esopus Creek confluence. The levee begins on Bushnellsville Creek immediately downstream of the County Route 47 bridge. It extends 155 feet along the left bank of Bushnellsville Creek. The levee then turns and runs along the left bank of Esopus Creek for an additional 445 feet (Figure 2-7).

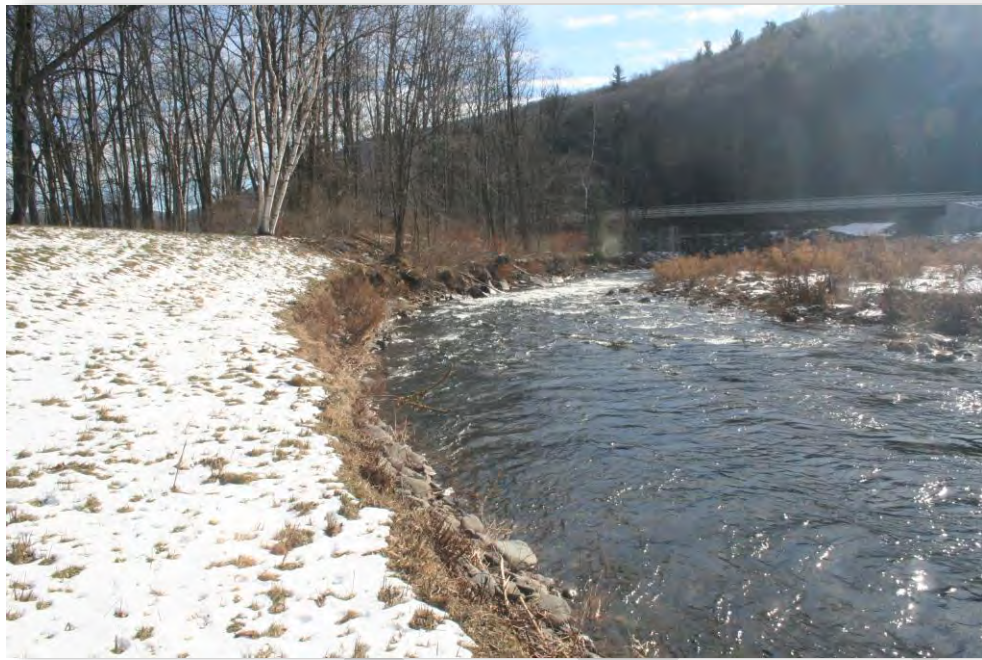
Since the repairs were made in 2011, the levee has experienced erosion at the downstream end. This erosion is due to the change in course of the Esopus Creek. Prior to Tropical Storm Irene, Esopus Creek ran parallel to the lower portion of the levee. However, following Tropical Storm Irene, the channel cut through the floodplain on the right bank, and the course of the stream was diverted directly toward the lower portion of the levee.

Figure 2-8
Erosion along Flood Control Levee in Shandaken

- The flood control levee that currently lines the left bank of the Bushnellsville Creek and Esopus Creek confluence was breached in 2011, resulting in significant damage. Since repairs were made in 2011, the levee has experienced erosion at the downstream end. Further evaluation of the levee is recommended, and armoring of the levee in the area of the erosion is likely warranted.

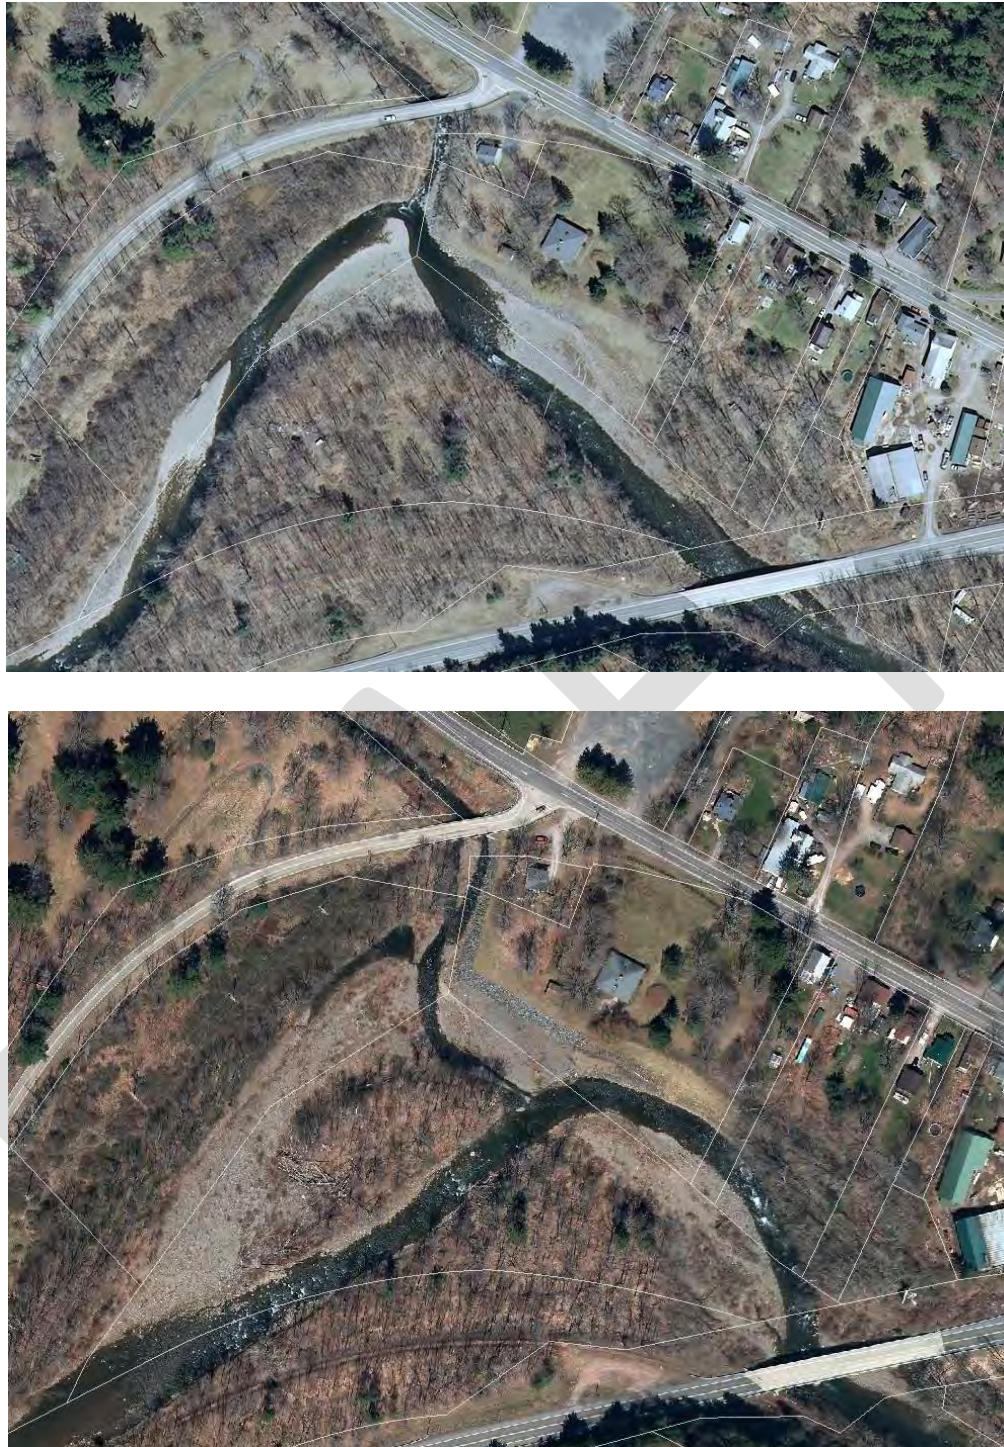
Tropical Storm Irene dramatically altered the stream channels at the Esopus Creek/Bushnellsville Creek confluence (Figure 5-1). The Esopus Creek avulsed toward the south, and as a result, the confluence moved approximately 240 feet downstream of its previous location. Although the survey form is dated October 11, 2011, the HEC-RAS model clearly uses pre-Irene channel geometry. This is clearly shown by the location of the main channel and the bank stations at cross section 78961 in the model relative to their current physical locations.

Figure 4-1
Aerial View of Esopus Creek/Bushnellville Creek Confluence in 2009 (top) and 2016 (bottom)

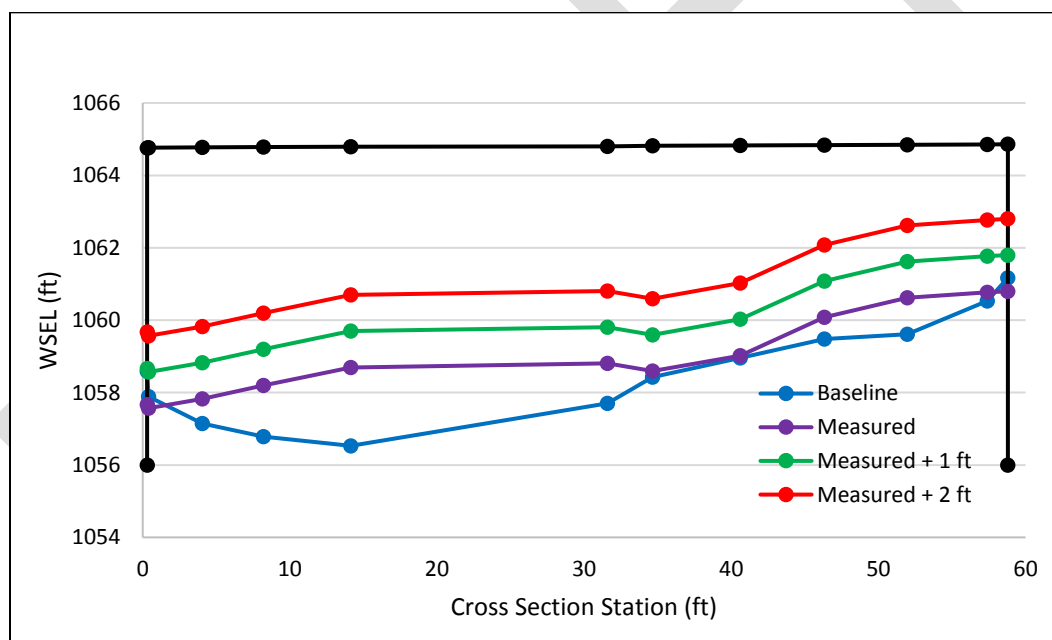
The new channel elevations at the bridge were modeled in HEC-RAS to assess the effect of water surface elevations in the region of the bridge. Additionally, 1- and 2-foot increases above the measured elevations in the channel were modeled to simulate sediment aggradation as well as bridge blockage due to debris (Figures 4-18 and 4-19).

Figure 4-18
Creekside Drive Bridge Opening Conditions Simulated in HEC-RAS

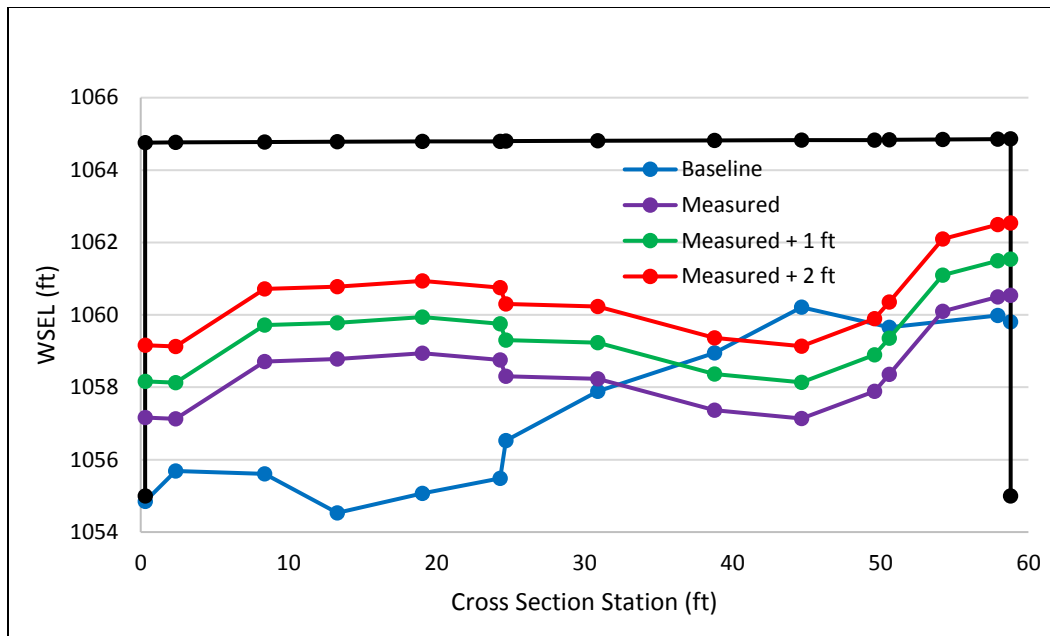
Figure 4-19
Creekside Drive Bridge Exit Conditions Simulated in HEC-RAS

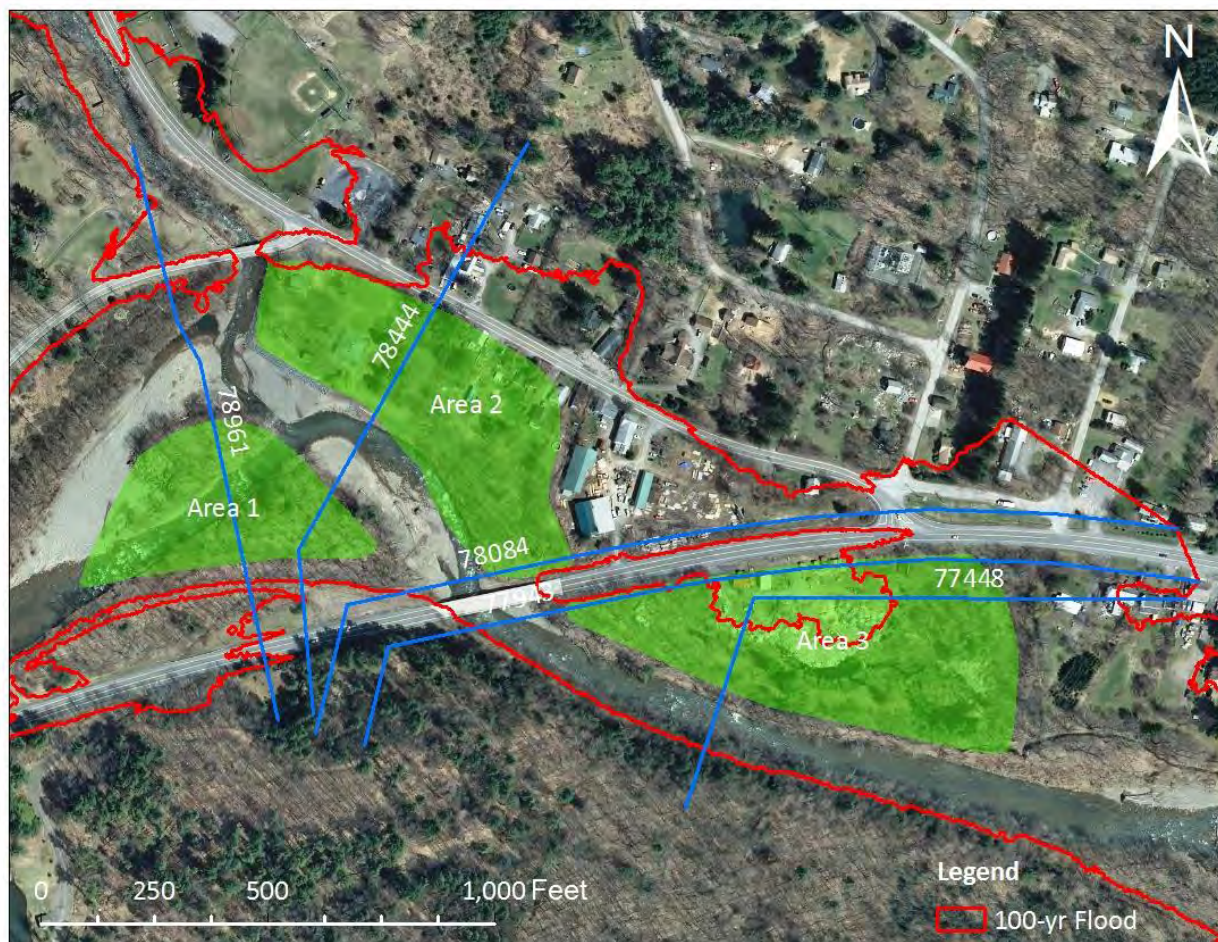
- Scenario 1: Removal of gravel bars and enhancement of the floodplain on the right bank upstream of the State Route 28 bridge (Area 1)
- Scenario 2: Removal of the levee on the left bank between Bushnellsville and Esopus Creeks (Area 2)
- Scenario 3: Enhancement of floodplain on the left bank downstream of the State Route 28 bridge (Area 3)
- Scenario 4: This is a combination of Scenarios 1 and 2 (Areas 1 and 2).
- Scenario 5: This is a combination of Scenarios 1, 2, and 3 (Areas 1, 2, and 3).

Figure 4-24
Areas of Floodplain Enhancement at the Confluence of Esopus and Bushnellville Creeks

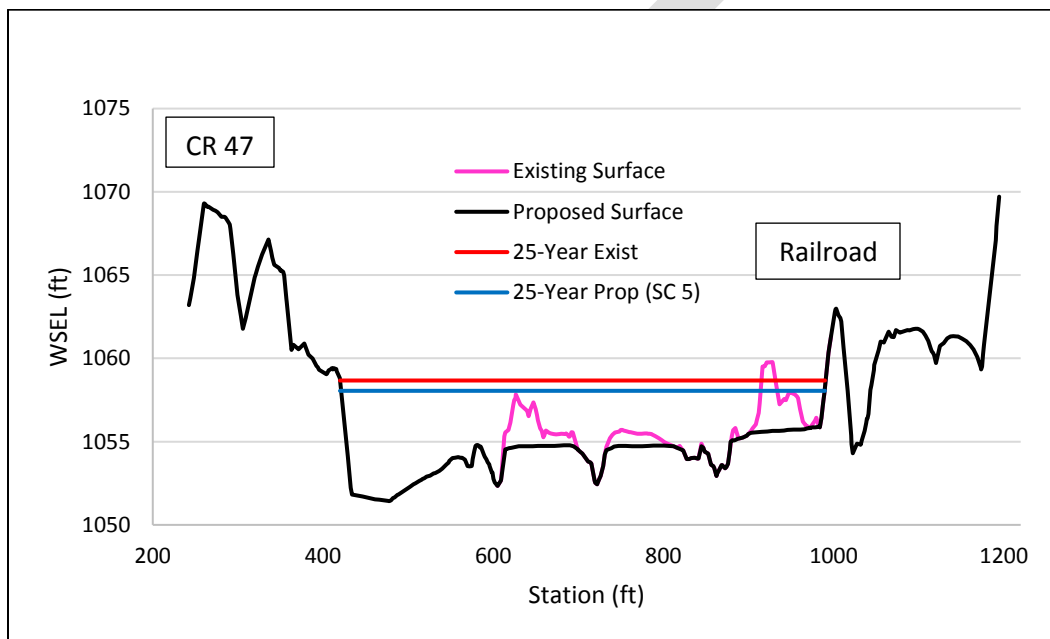
The figures illustrate that the largest flows do not inundate County Route 47 and do not overtop the railroad trestle on the right bank of the stream. As no houses are located in the vicinity of this cross section, there are no flood mitigation benefits at this particular location.

Figure 4-25
XS 78961 Floodplain Enhancement: 25-Year Discharge

Figure 4-26
XS 78961 Floodplain Enhancement: 50-Year Discharge

Figure 4-27
XS 78961 Floodplain Enhancement: 100-Year Discharge

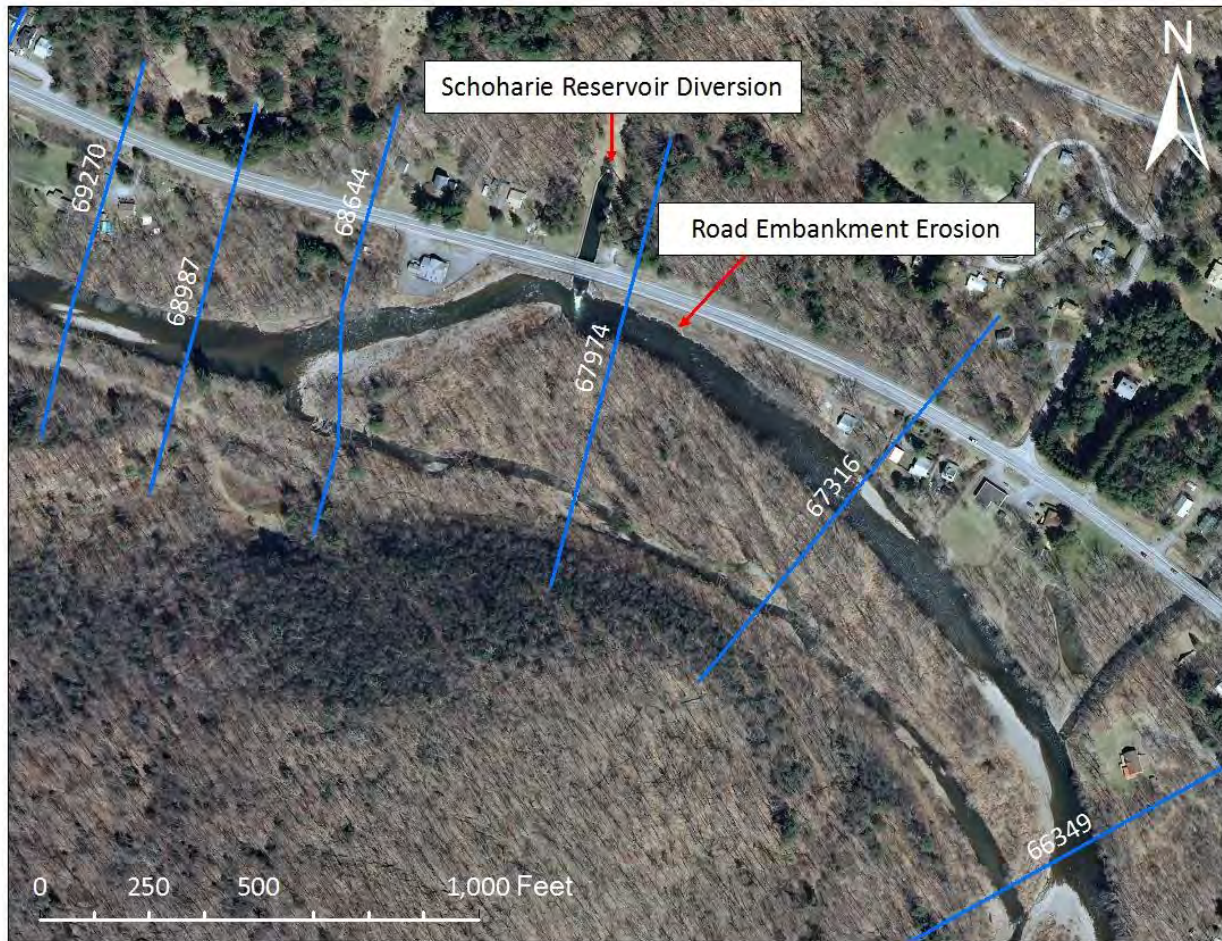
Figure 4-37
Pre-Irene Channel Conditions in the Vicinity of the Shandaken Tunnel

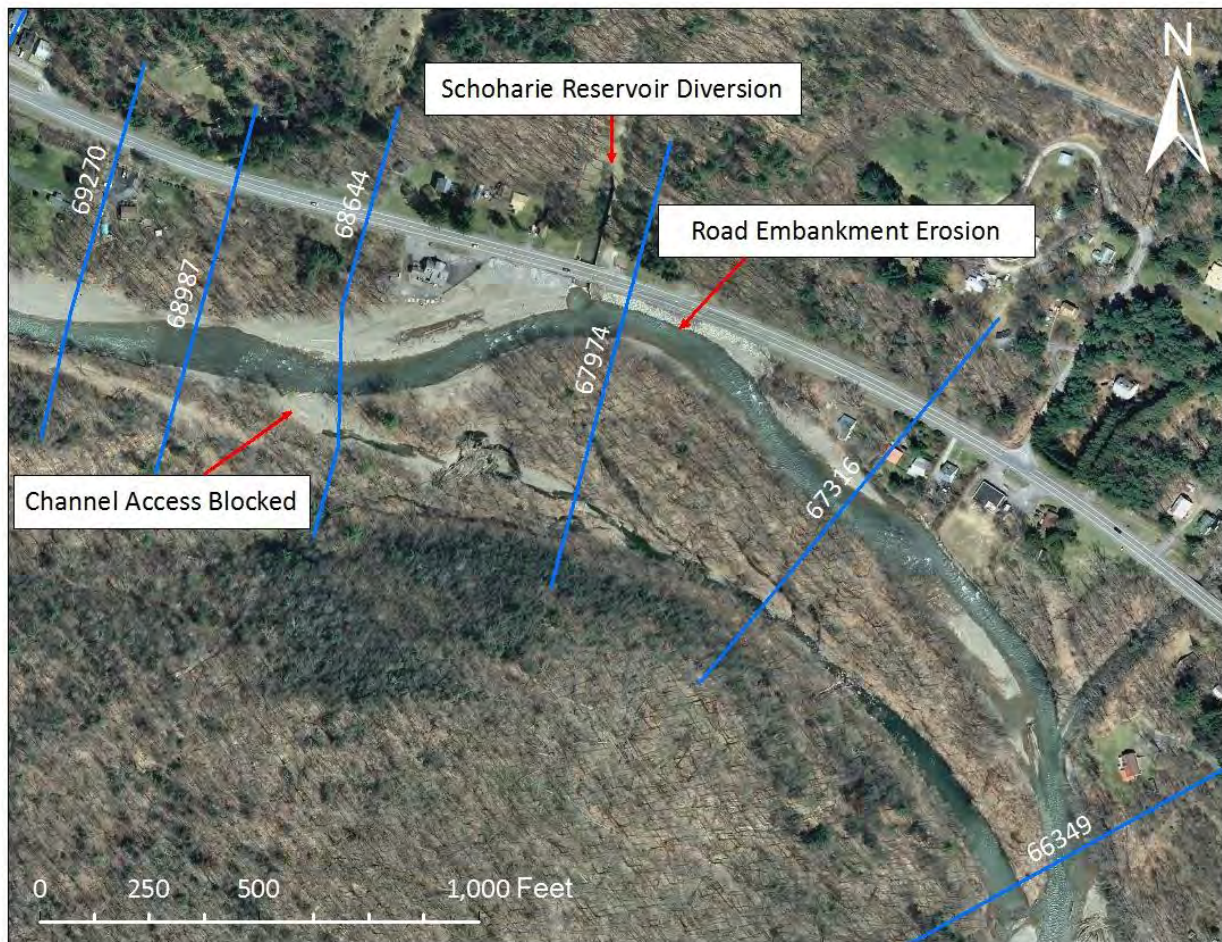
Figure 4-38
Post-Irene Channel Conditions in the Vicinity of the Shandaken Tunnel

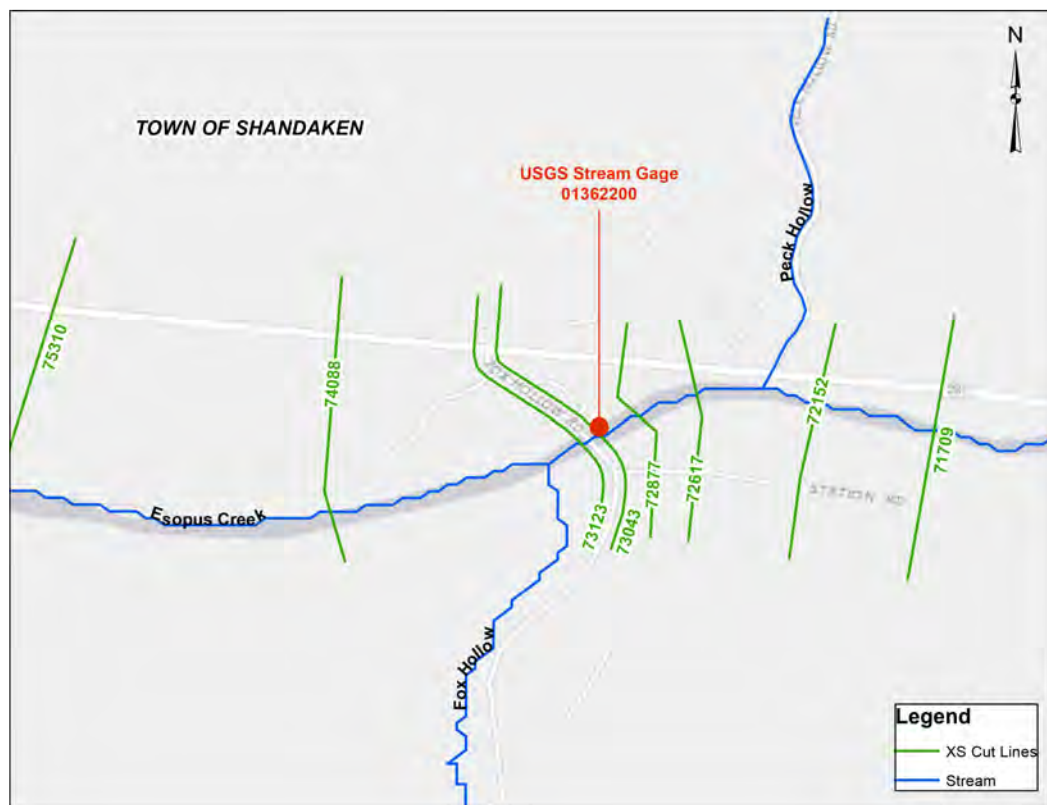
Figure 1. Esopus Creek HEC-RAS model in the vicinity of USGS stream gage 01362200.
