# HAMLET OF PINE HILL LOCAL FLOOD ANALYSIS

**Town of Shandaken, New York**

SLR #142.14615.00030

November 2022

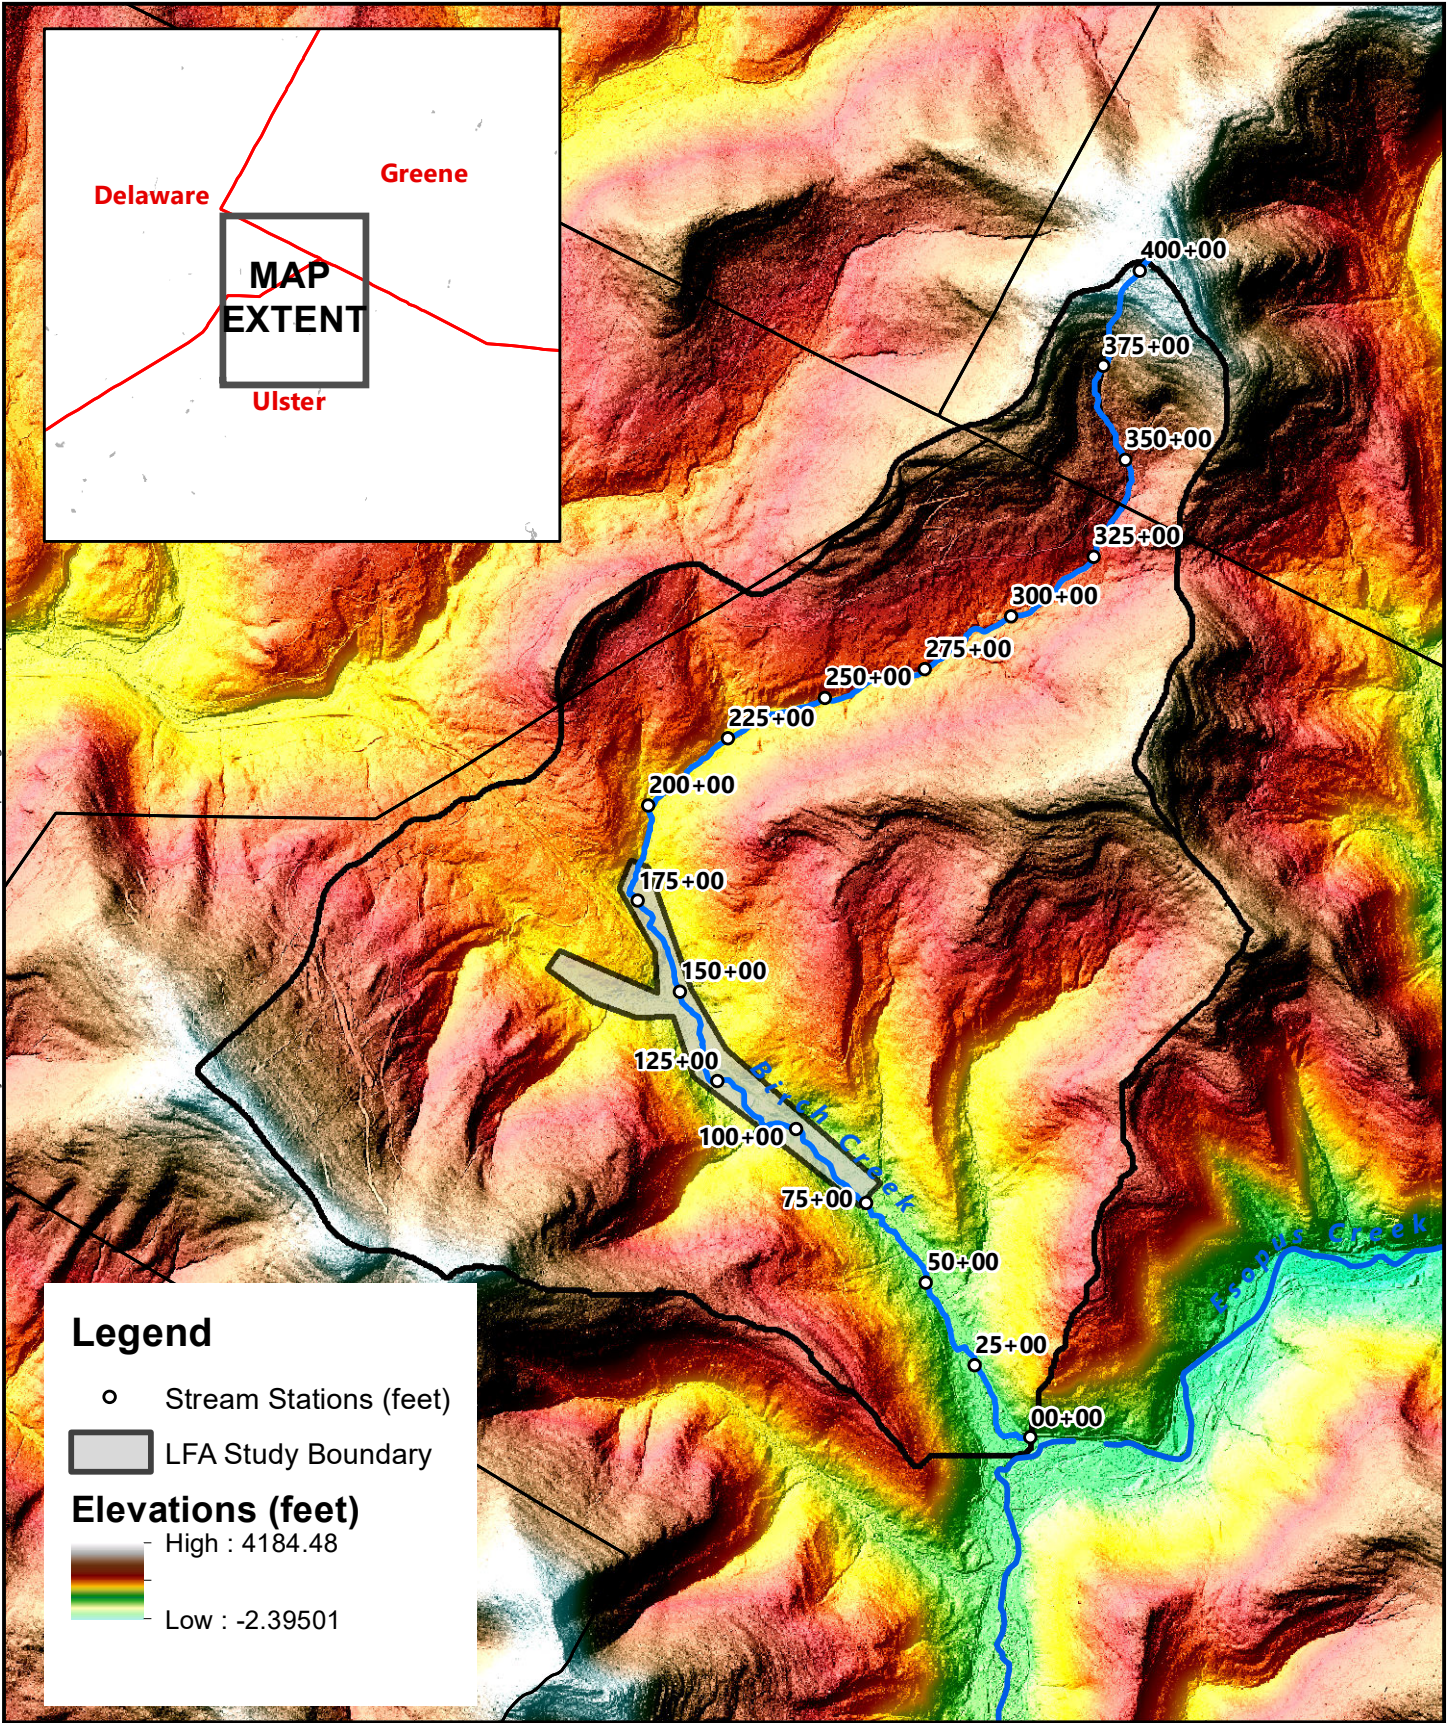
231 MAIN STREET SUITE 102 NEW PALTZ, NY 12561 845.633.8153	<b>RELIEF MAP</b> LOCAL FLOOD ANALYSIS HAMLET OF PINE HILL ULSTER COUNTY, NEW YORK		SCALE 1" = 6,000'
			DATE 10/25/2022
			PROJ. NO. 142.14615.00030
			<b>FIG. 2-2</b>

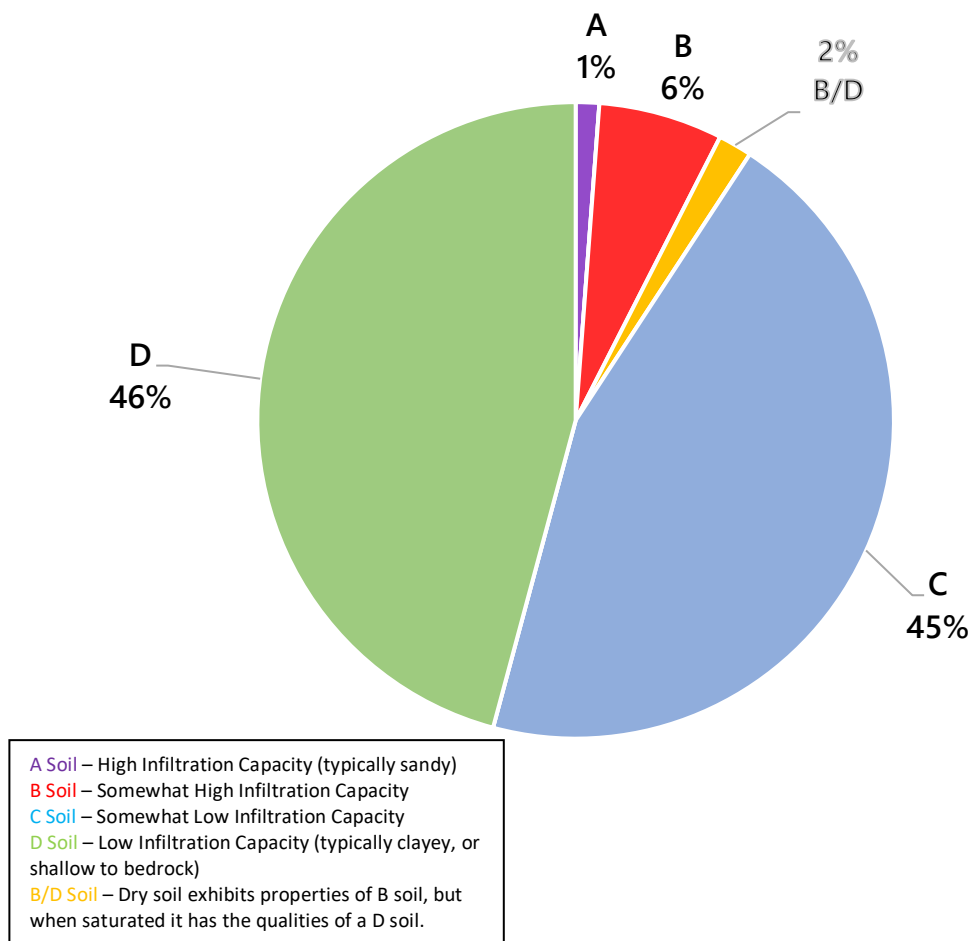
**Figure 2-3: Hydrologic Grouping of Soils within the Birch Creek Watershed**

During a rainfall event, the proportion of rainfall that runs off directly into rivers and streams or that infiltrates into the ground is greatly influenced by the composition of soils within a watershed. Soils are assigned a hydrologic soil group identifier, which is a measure of the infiltration capacity of the soil. These are ranked A through D. A hydrologic soil group A soil is often very sandy, with a high infiltration capacity and a low tendency for runoff except in the most intense rainfall events; a D-ranked soil often has a high silt or clay content or is very shallow to bedrock and does not absorb much stormwater, which instead is prone to runoff even in small storms. A classification of B/D indicates that when dry the soil exhibits the properties of a B soil, but when saturated, it has the qualities of a D soil. Over 91 percent of the mapped soils in the Birch Creek watershed are classified as hydrologic soil group C or D, indicating a low capacity for infiltration and a high tendency for runoff (Figure 2-3).

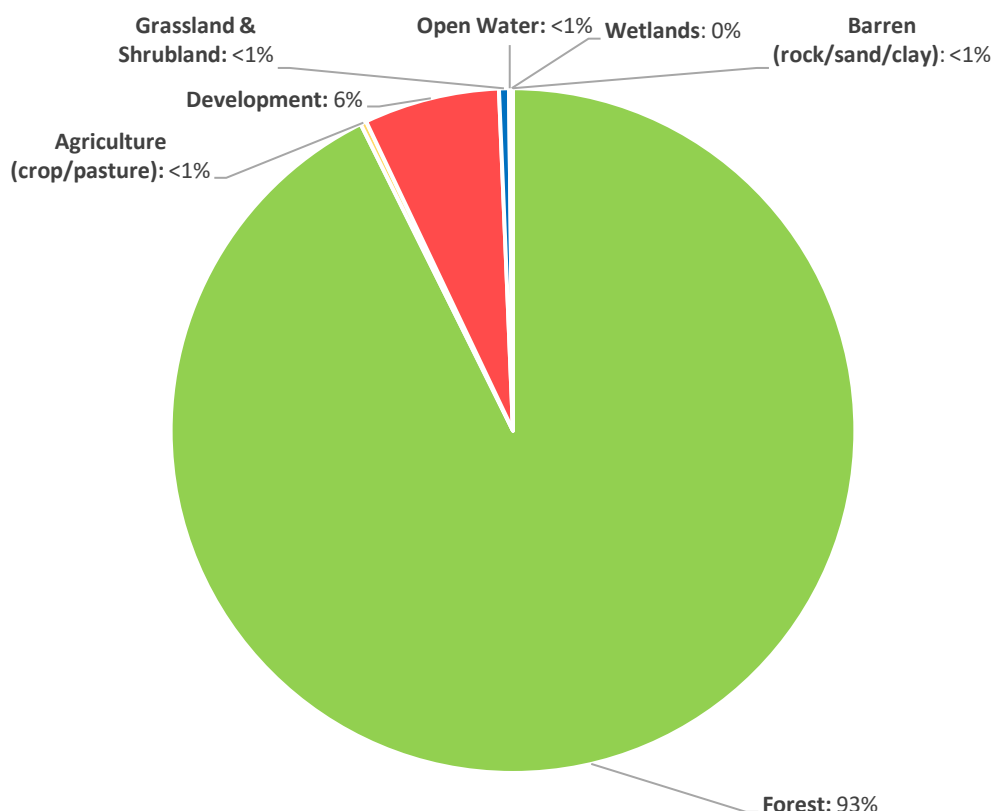
**Figure 2-4: Land Cover within the Birch Creek Watershed**

Forested land makes up 93 percent of the Birch Creek watershed. Developed land makes up 6 percent. The remaining 1 percent of land cover consists of agricultural land, grassland and shrubland, open water, wetlands, and barren land (Figure 2-4). A portion of Belleayre Mountain Ski Center is located in the northeast corner of the watershed. The ski center artificially makes snow and utilizes several ponds in the watershed to produce the snow.

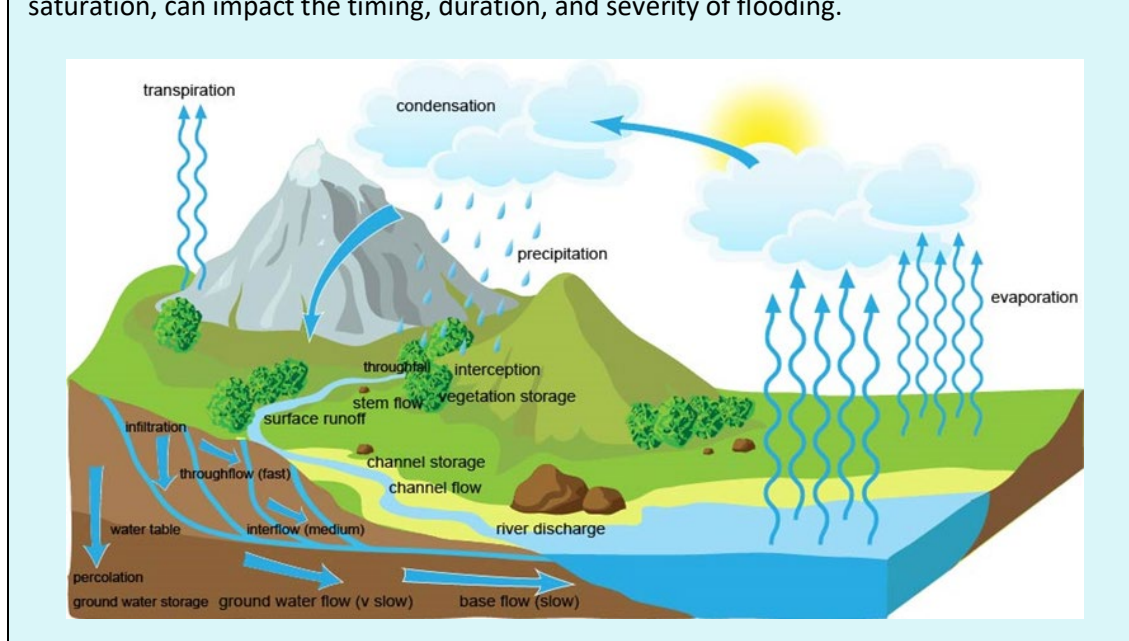
**Figure 2-6: Diagram of Simplified Hydrologic Cycle**

Along with the location, duration, and intensity of a storm, the flooding that may result from a rainfall event can vary widely depending on the unique hydrology of each basin. Characteristics of local topography, soils, vegetation cover and type, bedrock geology, land use and cover, river hydraulics and floodplain storage, ponding, wetland, and reservoir storage, combined with antecedent conditions in the watershed such as snowpack or soil saturation, can impact the timing, duration, and severity of flooding.

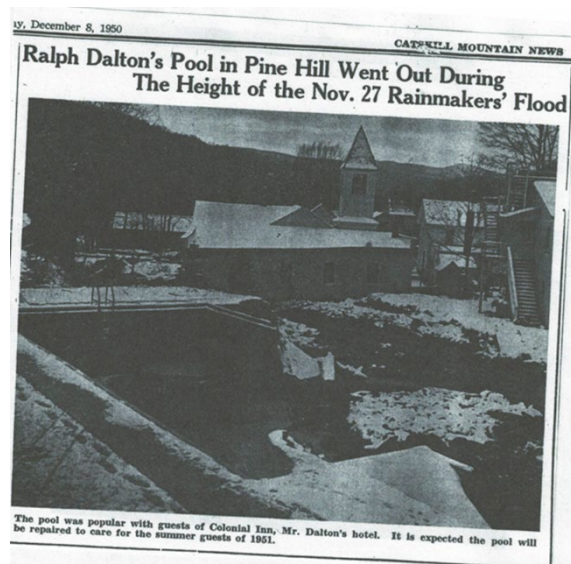
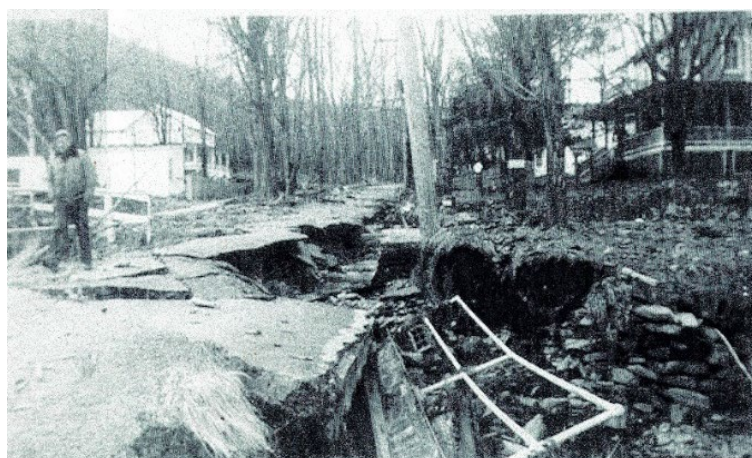
Figure 3-1: Photos depicting flooding damage in Pine Hill due to the Rainmaker flood event in November 1950. Photo Sources: Catskill Mountain News

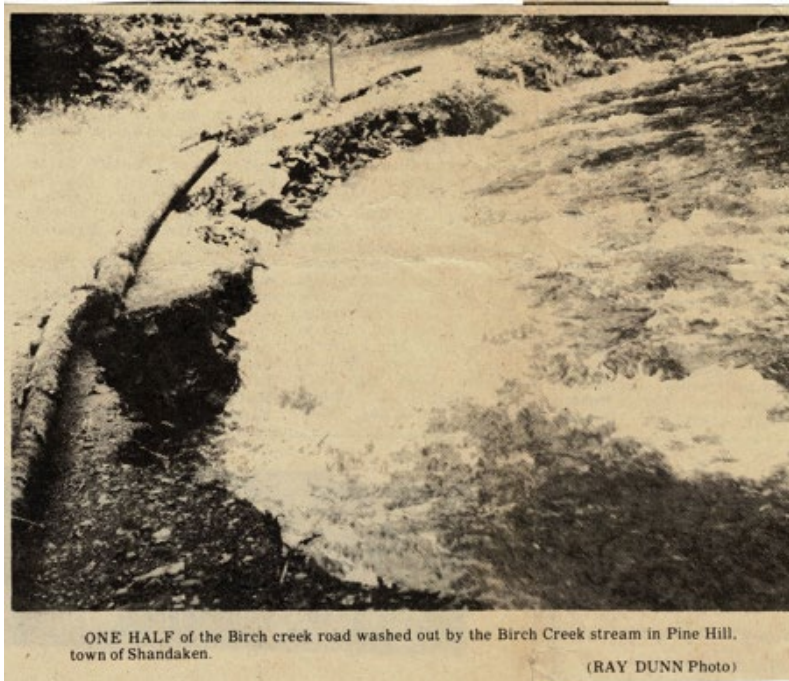
Figure 3-2: A photo depicting flood damage within the hamlet of Pine Hill on Birch Creek Road during the July 1973 event. Photo Source: Catskill Mountain News

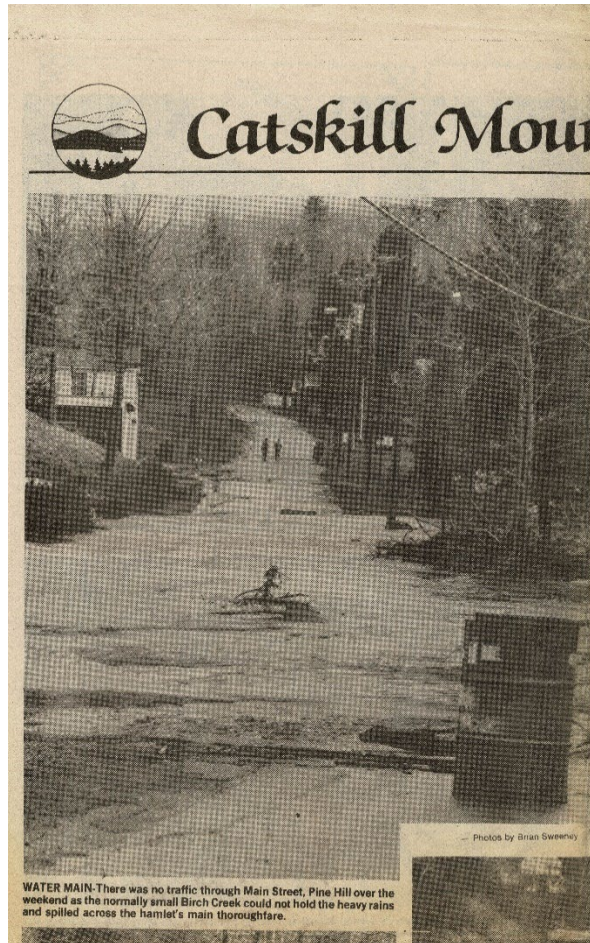
Figure 3-3: A photo depicting flooding across Main Street (left) and flood damage within the hamlet of Pine Hill on Upper Main Street bridge during the April 1987 event (below). Photo Source: Catskill Mountain News (left) and Daily Freeman (below)

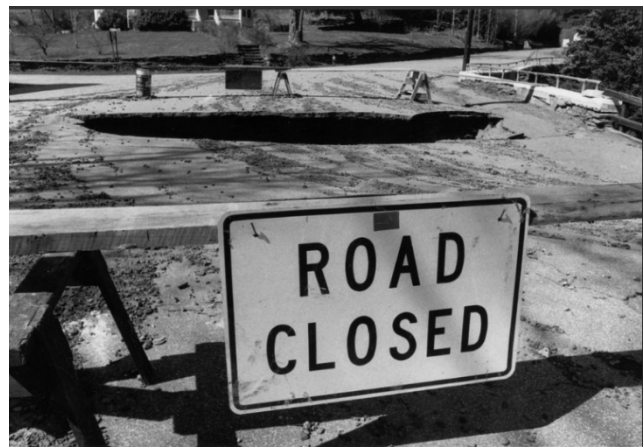
Figure 3-4: A photo depicting flood damage within the hamlet of Pine Hill during the April 1987 event. Photo Source: Aaron Bennett, NYCDEP

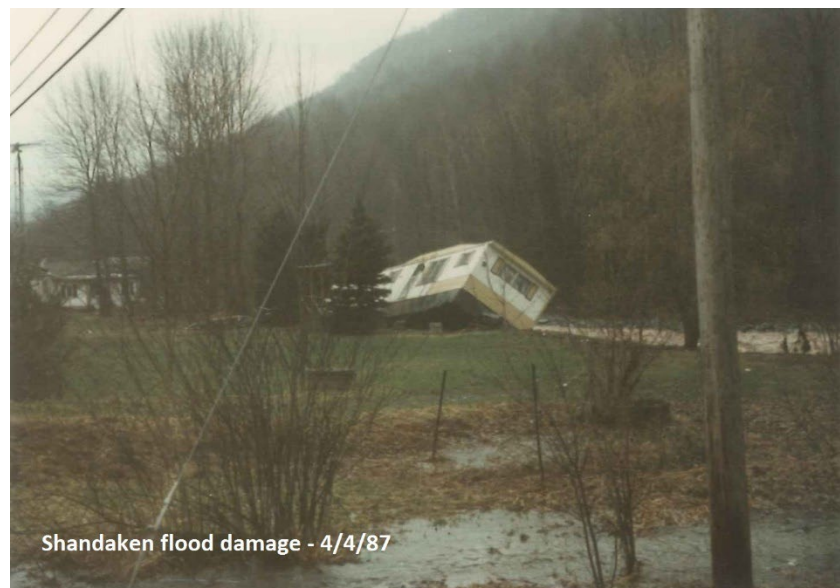
Figure 3-5: A photo depicting flood damage within the hamlet of Pine Hill on lower Main Street bridge during the January 1996 event. Photo Source: Catskill Mountain News

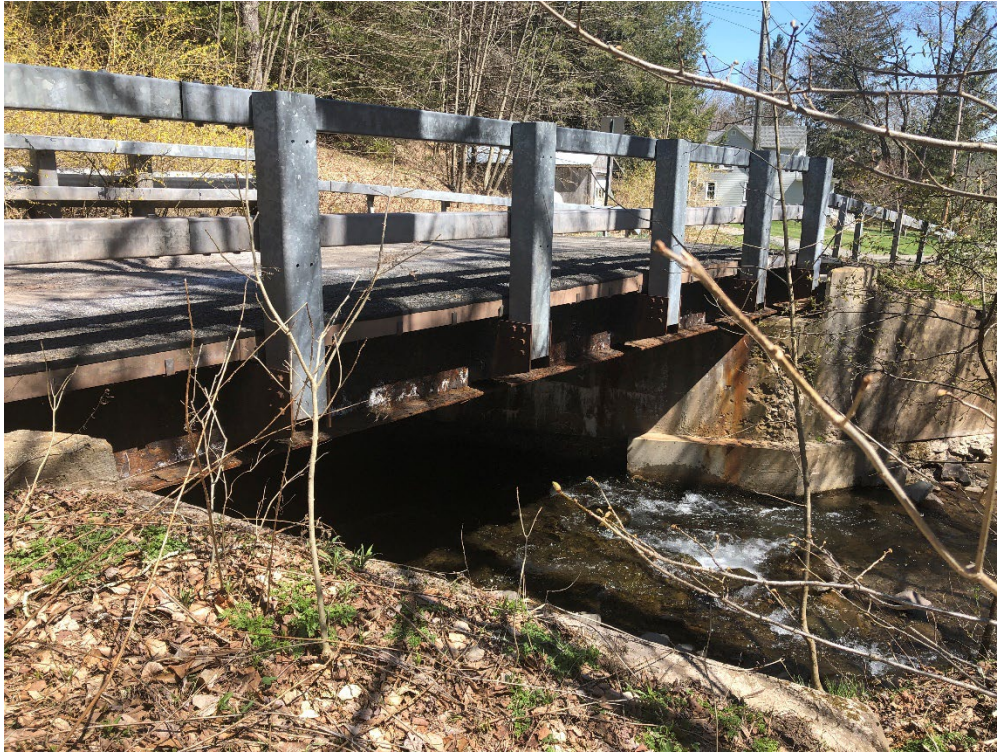
**Figure 4-3: Outlet of county bridge over Alton Creek**

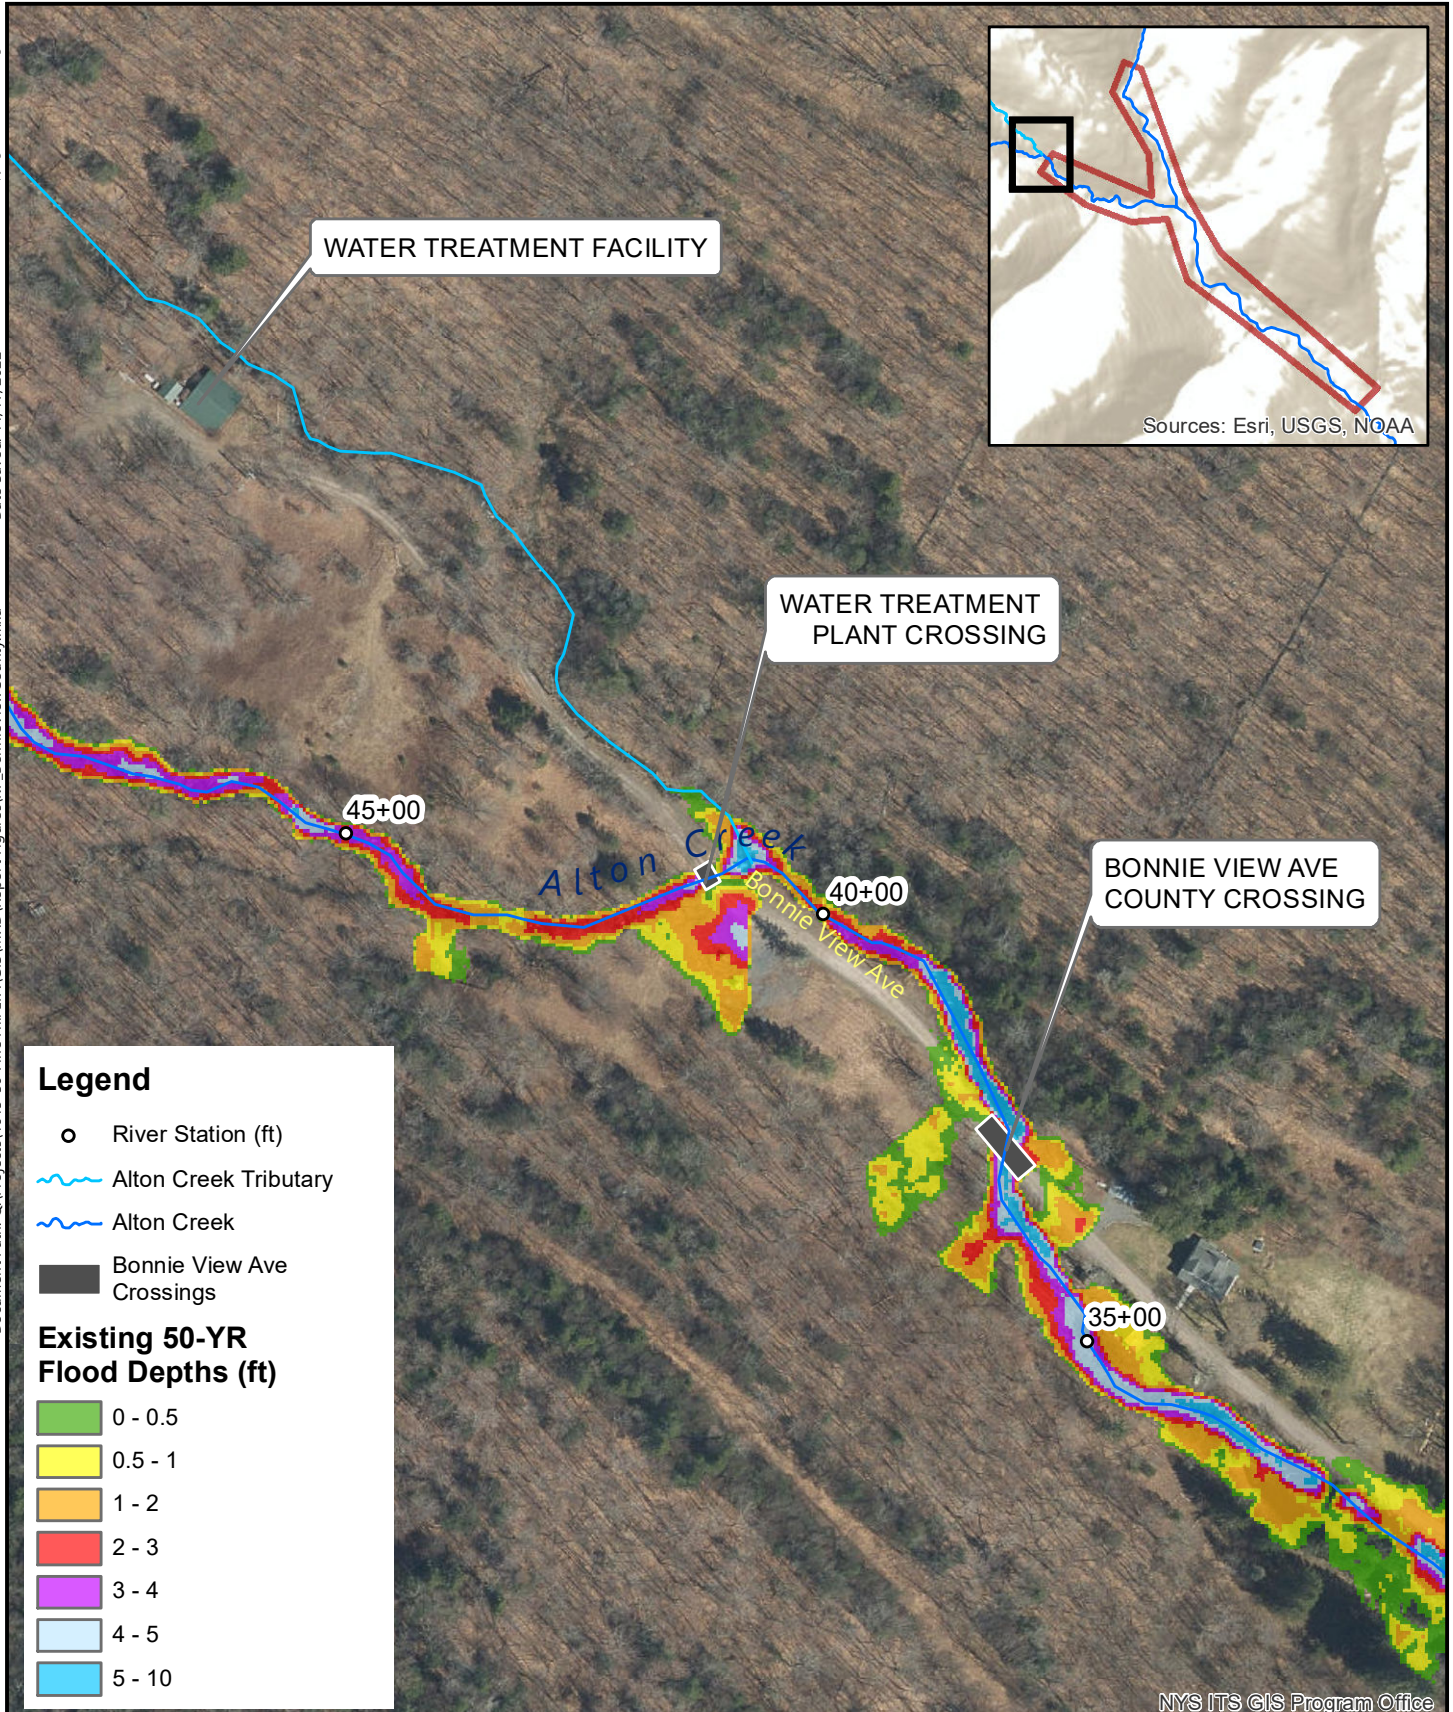
231 MAIN STREET SUITE 102 NEW PALTZ, NY 12561 845.633.8153	BONNIE VIEW AVE COUNTY CROSSINGS: EXISTING CONDITIONS 50-YEAR		SCALE 1" = 177'
	PINE HILL LOCAL FLOOD ANALYSIS		DATE 11/17/2022
	HAMLET OF PINE HILL		142.14615.00030
	ULSTER COUNTY		PROJ. NO.
NEW YORK		<b>FIG. 4-5</b>

Figure 4-4 is a concept map of proposed changes to the Bonnie View Avenue county bridge and crossing to the water treatment facility ([Section 4.2.4](#)). Figure 4-5 is a map of the 50-year flows under existing conditions. Figure 4-6 is a map of the 50-year flows under proposed conditions. Figure 4-7 is a map of the 100-year flows under existing conditions. Figure 4-8 is a map of the 100-year flows under proposed conditions.

Figure 4-4 shows the proposed changes for the crossings. Figures 4-5 through 4-8 show the existing and proposed conditions for both a 50-year and 100-year flood event.

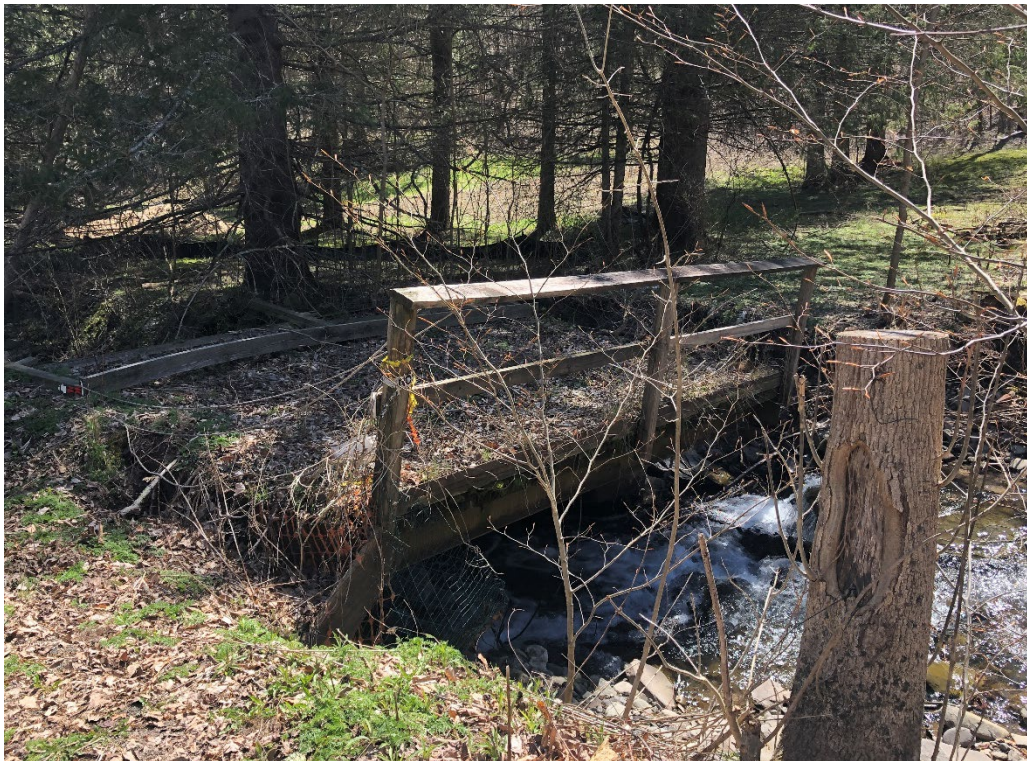
At river station 32+20, an abandoned private driveway crosses Alton Creek. The wood and metal structure sits on top of concrete abutments. The abutments are undercut, and the surface is no longer connected to either bank. The crossing overtops during flows less than the 10-year flood event, and it creates backwater flooding. This structure is a medium priority due to the risk of flooding Bonnie View Avenue. It is recommended for removal.

Figure 4-9: Overgrown private driveway bridge over Alton Creek

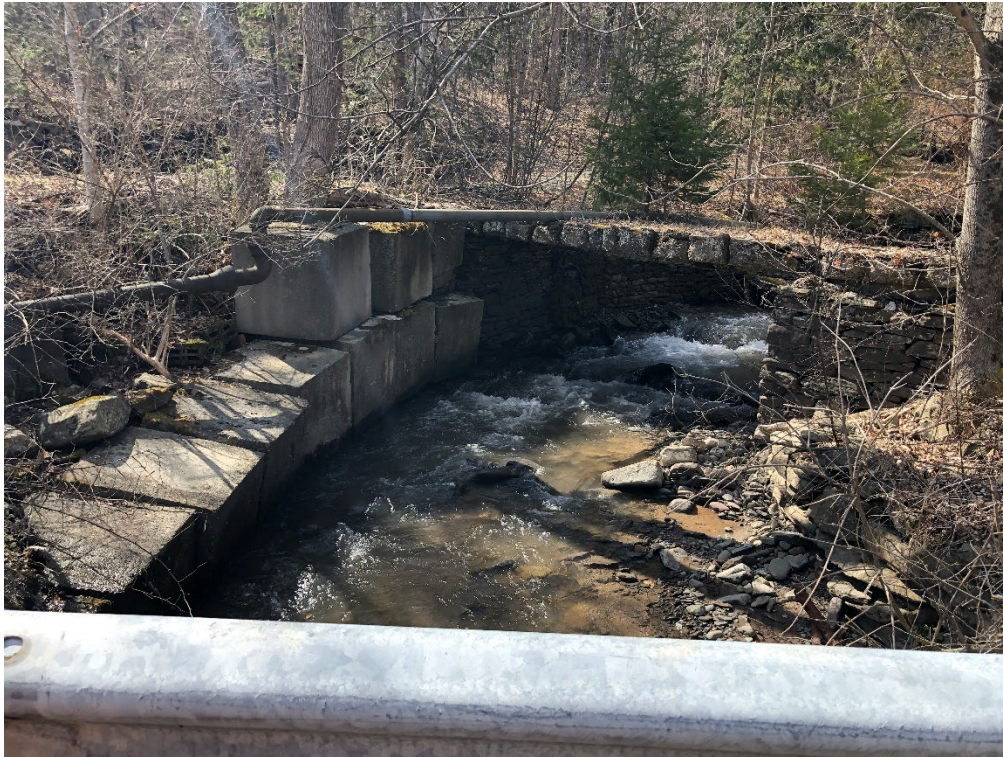
**Figure 4-10: Looking upstream at stone crossing with disconnected pipe**

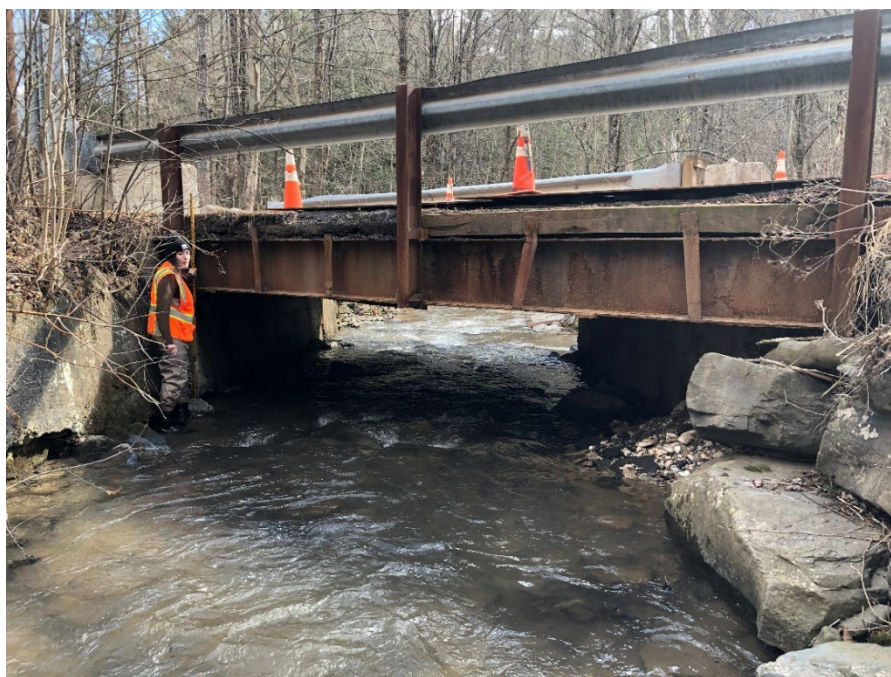
The current bridge passes the 10-year flood event without overtopping, but with backwater flooding, according to the HEC-RAS model. Overtopping of the bridge and flooding of Bonnie View Avenue may prevent passage and reduce access to some houses and the water treatment facility, a critical facility that must be accessible. There is a detour available via Mill Street and Station Road. However, the route is not passable by large vehicles such as fire trucks due to the rail bridge on Mill Street. Additionally, the route requires passage of two other floodprone locations - the Mill Street crossing (Project Area 3) and the intersection of Station Road and Bonnie View Avenue (Project Area 1). Based on the flood risk and poor structural condition, the bridge is a high priority for replacement. A full hydraulic and hydrological analysis is recommended to properly size the replacement bridge. Based on the HEC-RAS model, a 50-foot-span bridge, with the channel adjustments discussed below, can pass the current and future 50-year flows without overtopping.

**Figure 4-19: Looking downstream at the Bonnie View Avenue culvert inlet over Alton Creek**

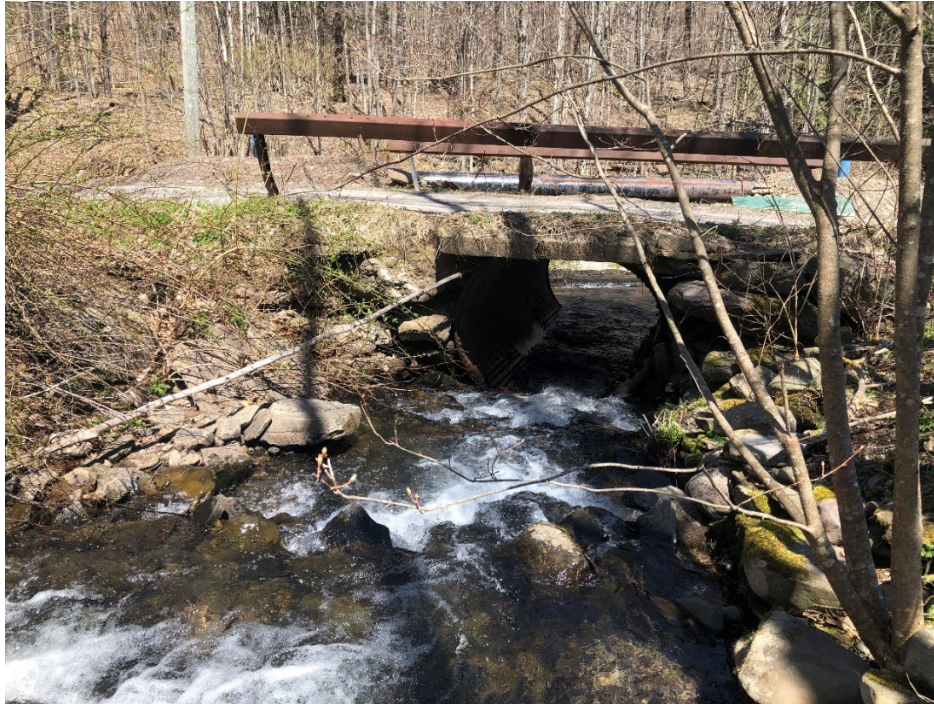
Figure 4-20: Inlet of culvert crossing Alton Creek

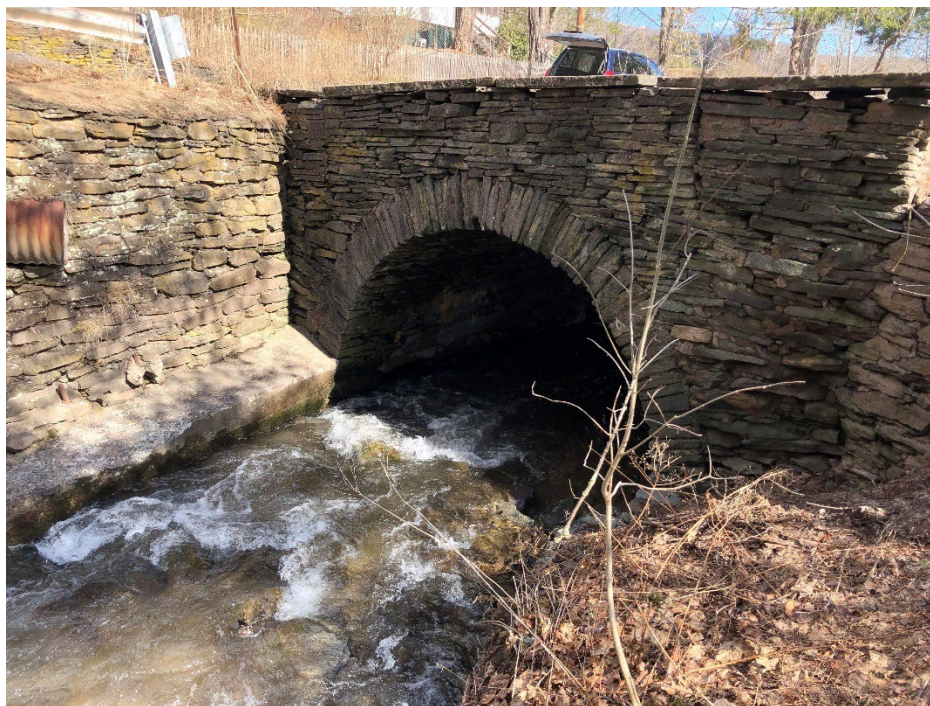
The existing culvert's capacity is sufficient to pass a 10-year flood event without overtopping. However, backwater flooding does occur. A detour is possible via Bonnie View Avenue and Station Road. However this detour is not passable by large vehicles such as fire trucks and includes two other floodprone areas – Project Areas 1 and 2. The flood risk at this crossing makes it a medium priority for replacement. Channel widening is also recommended in this area. A full hydraulic and hydrological assessment of the crossing, including any changes to the channel, is recommended to properly size the replacement structure. In concert with the channel changes recommended below, a 35-foot-span bridge will reduce backwater flooding and has the capacity to pass a current 100-year flood and future 50-year flood.

**Figure 4-21: Looking downstream at the inlet of the Mill Street culvert over Alton Creek**

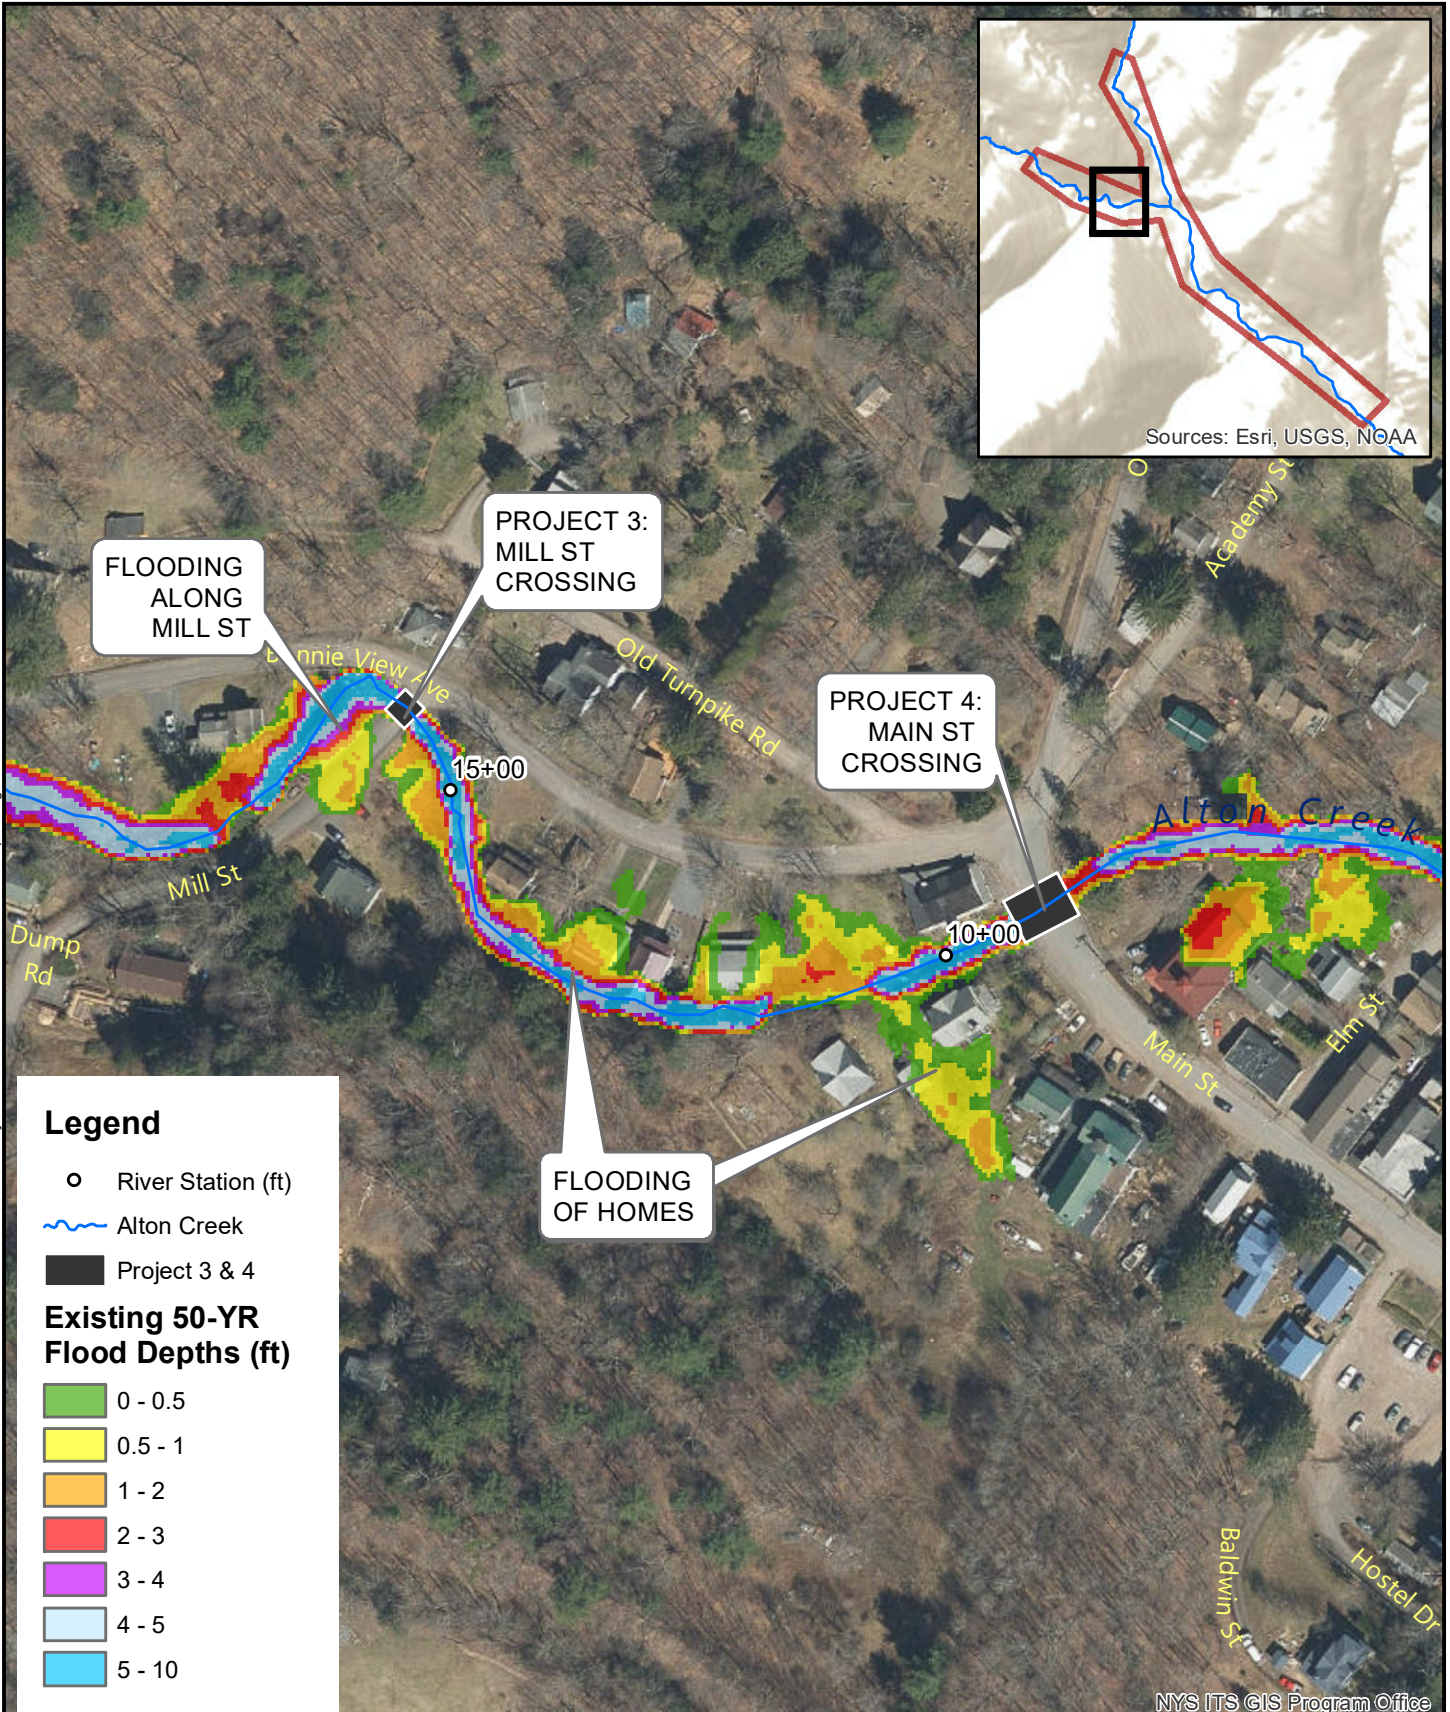
<p>231 MAIN STREET SUITE 102 NEW PALTZ, NY 12561 845.633.8153</p>	<p><b>PROJECT 3 &amp; PROJECT 4: EXISTING CONDITIONS 50-YR</b></p> <p>PINE HILL LOCAL FLOOD ANALYSIS HAMLET OF PINE HILL</p> <p>ULSTER COUNTY NEW YORK</p>		<p>SCALE 1" = 150'</p>
			<p>DATE 11/17/2022</p>
			<p>142.14615.00030</p>
			<p>PROJ. NO.</p>
			<p><b>FIG. 4-23</b></p>

Figure 4-22 is a concept map of proposed changes to the Mill Street and Main Street bridges (Project Areas 3 and 4). Figure 4-23 is a map of the 50-year flows under existing conditions. Figure 4-24 is a map of the 50-year flows under proposed conditions. Figure 4-25 is a map of the 100-year flows under existing conditions. Figure 4-26 is a map of the 100-year proposed conditions.

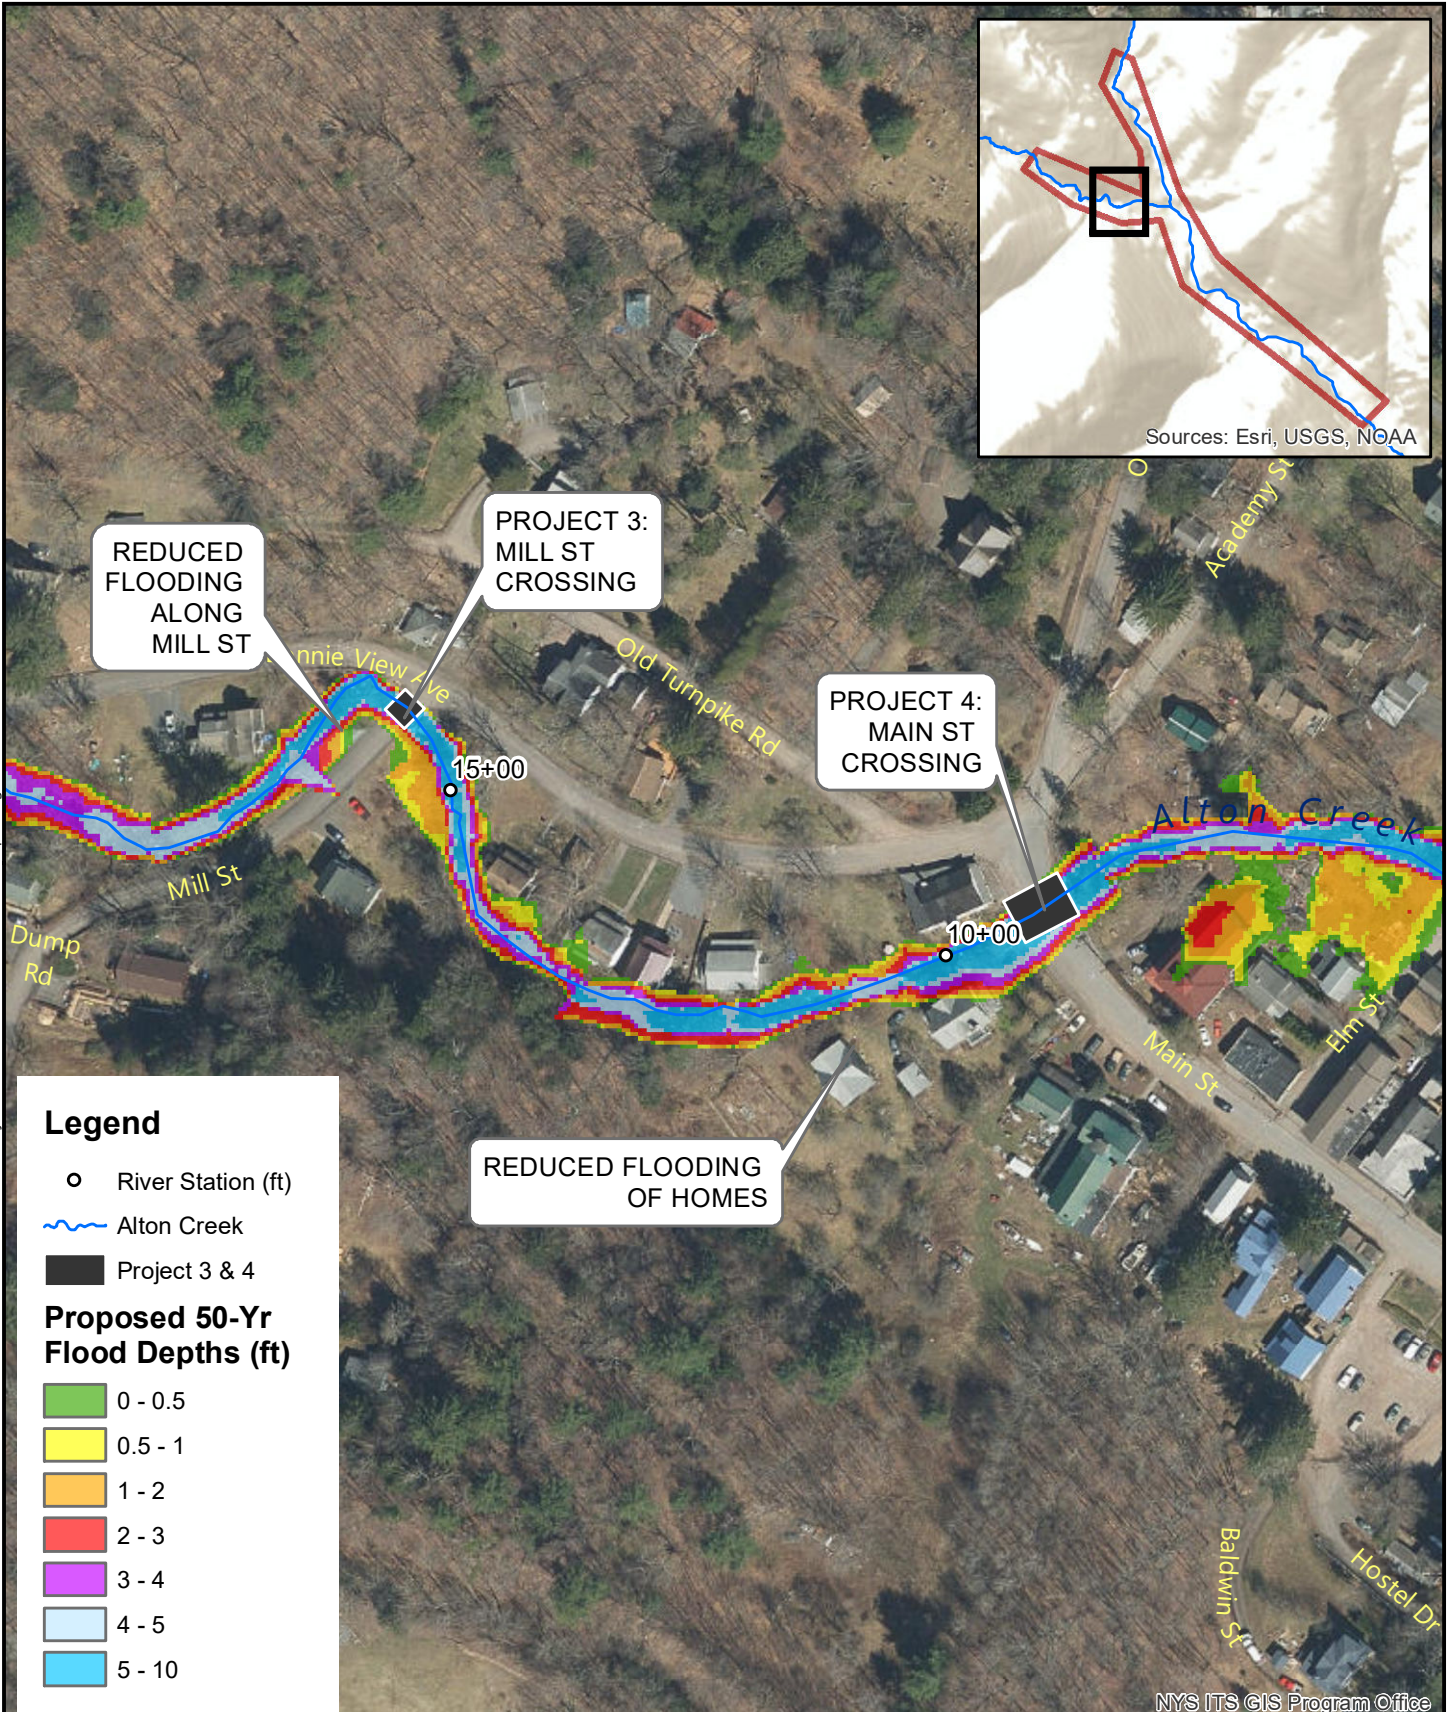
231 MAIN STREET SUITE 102 NEW PALTZ, NY 12561 845.633.8153	<b>PROJECT 3 &amp; PROJECT 4: PROPOSED CONDITIONS 50-YR</b>		SCALE 1" = 150'
	PINE HILL LOCAL FLOOD ANALYSIS		DATE 11/17/2022
	HAMLET OF PINE HILL		142.14615.00030
	ULSTER COUNTY NEW YORK		PROJ. NO.
			<b>FIG. 4-24</b>

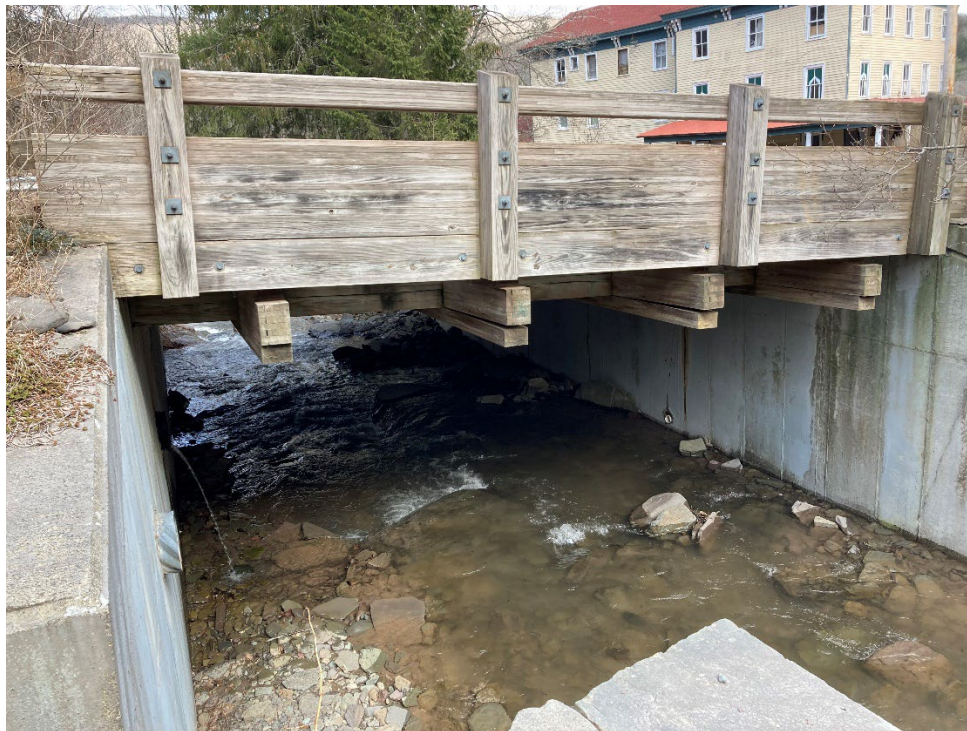
A replacement design should also include channel widening as described below. A full hydraulic and hydrological assessment is recommended to properly size a new bridge. This assessment should also include the channel changes. Based on a HEC-RAS model with an increased channel width, a bridge with a span of 35 feet has the capacity to pass the 100-year current and future flood event without overtopping and reduced backwater flooding.

**Figure 4-27: Looking downstream at the inlet of the upper Main Street crossing over Alton Creek**

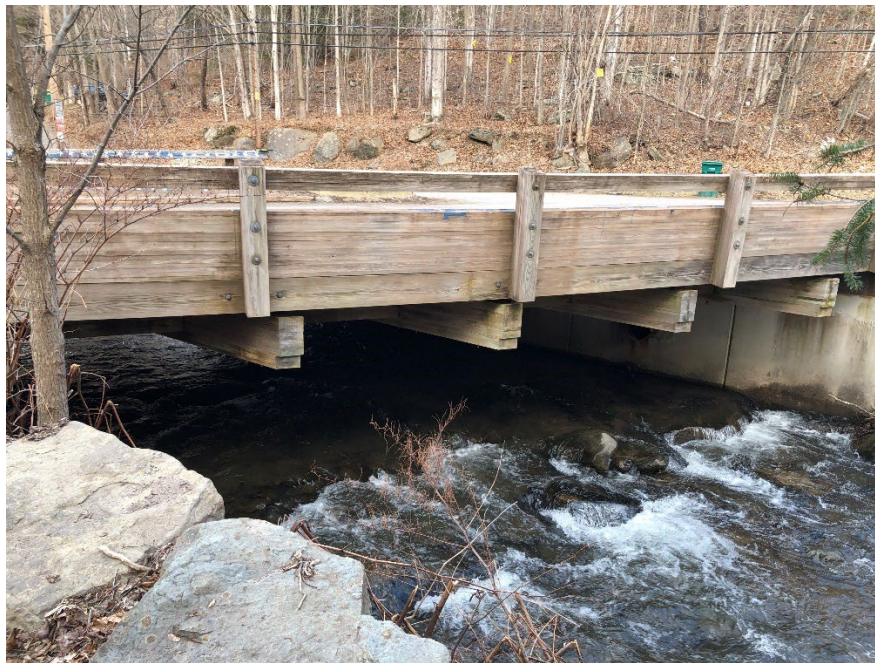
Replacement of this crossing is most effective if done in concert with channel and floodplain adjustments. A full hydraulic and hydrological study should be done to include the channel and floodplain changes to properly resize the crossing. With the channel widening and floodplain creation recommended in this study, the bridge span is recommended to be 60 feet to reduce backwater flooding. The increase in span only slightly reduces the risk of overtopping. Further widening of the bridge and floodplain will require the removal of one or both houses at the outlet.

**Figure 4-34: Looking downstream at the lower Main Street crossing over Birch Creek**
