# HAMLET OF PINE HILL LOCAL FLOOD ANALYSIS

**Town of Shandaken, New York**

SLR #142.14615.00030

November 2022

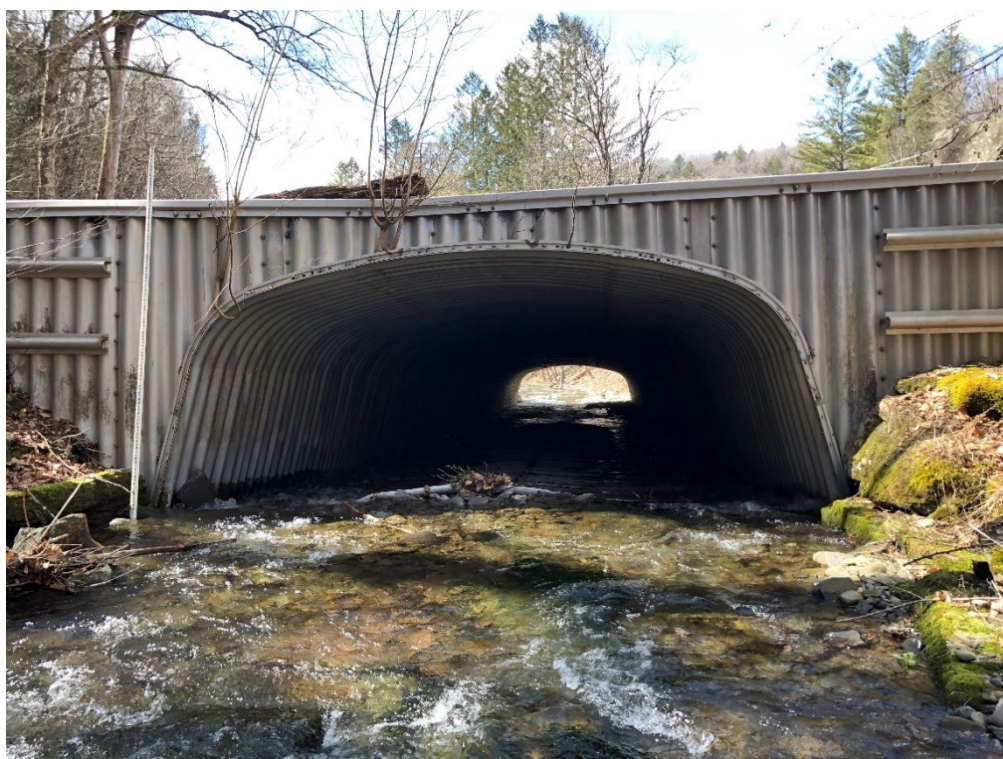
**Figure 4-40: Looking downstream at Birch Creek Road culvert over Birch Creek**

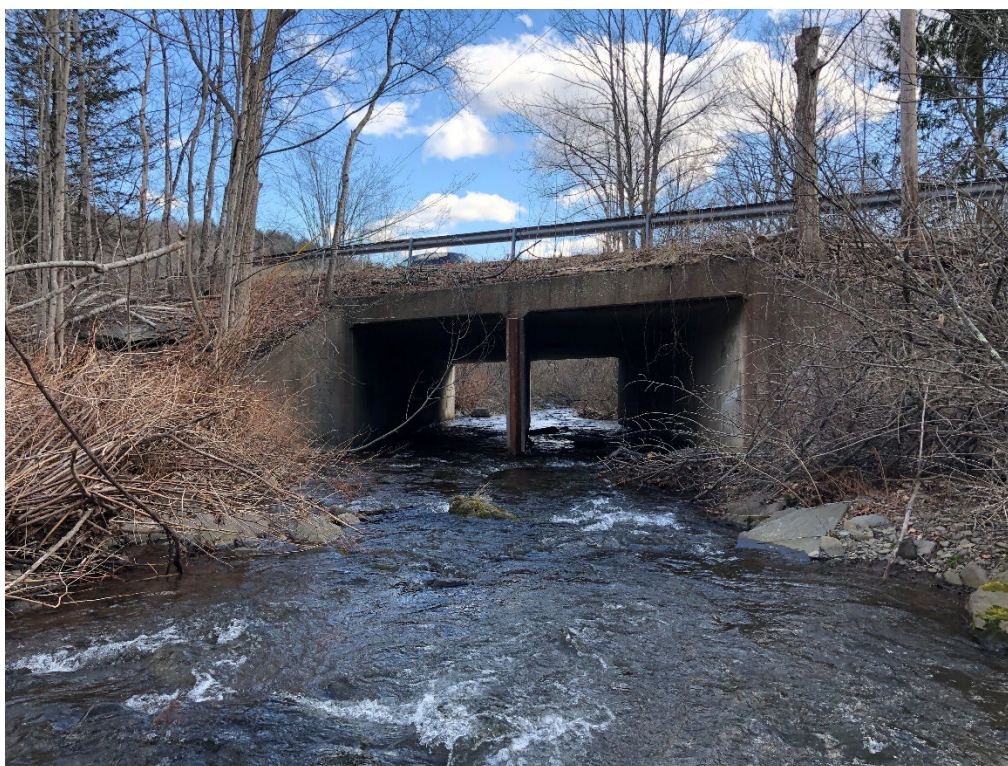
**Figure 4-41: Looking downstream at the Elm Street culvert over Birch Creek**

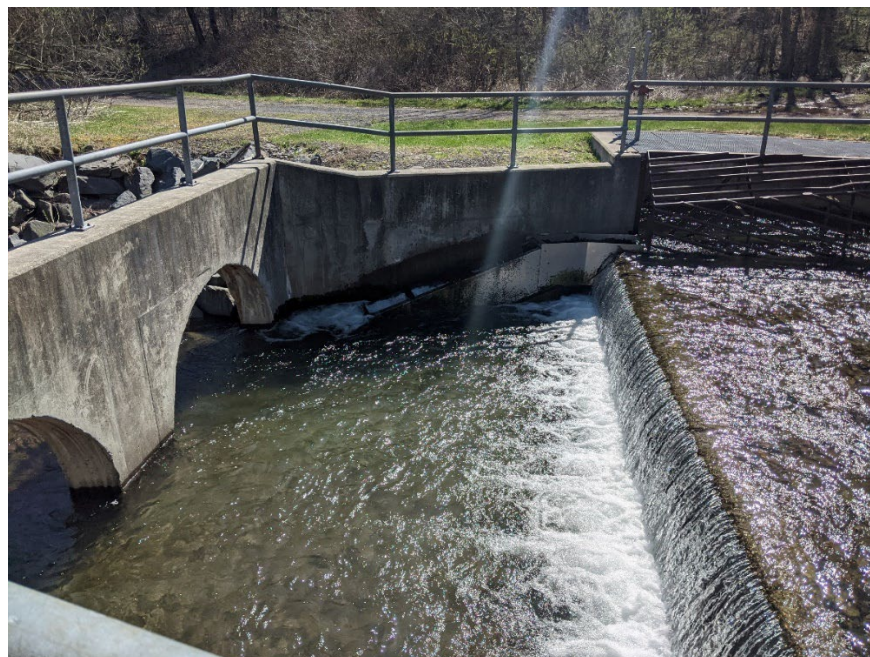
Figure 4-42: Dam, old road crossing, and intake for Belleayre Day Use Area

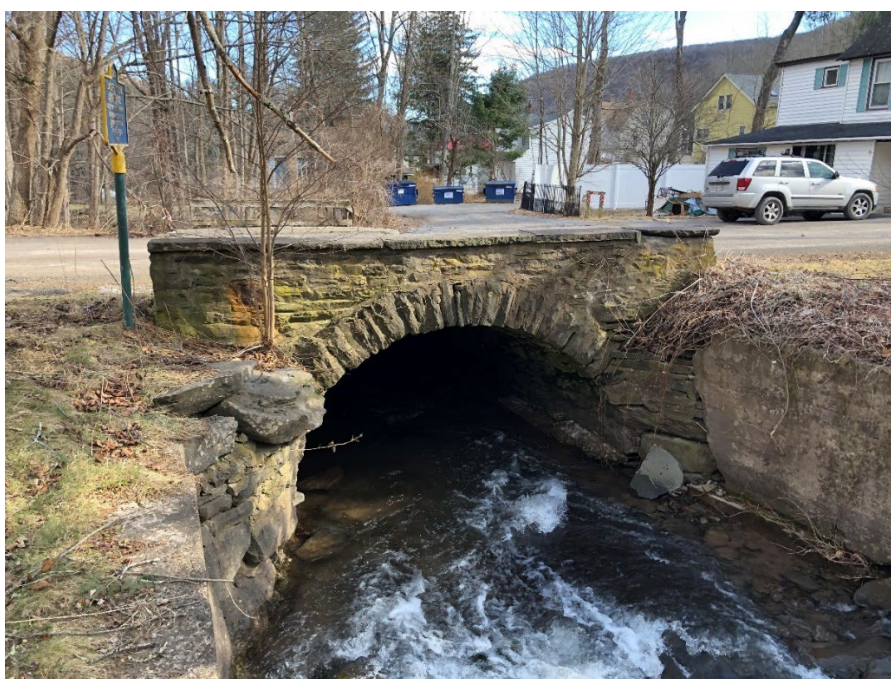
Figure 4-43: Historic Elm Street stone arch over Alton Creek

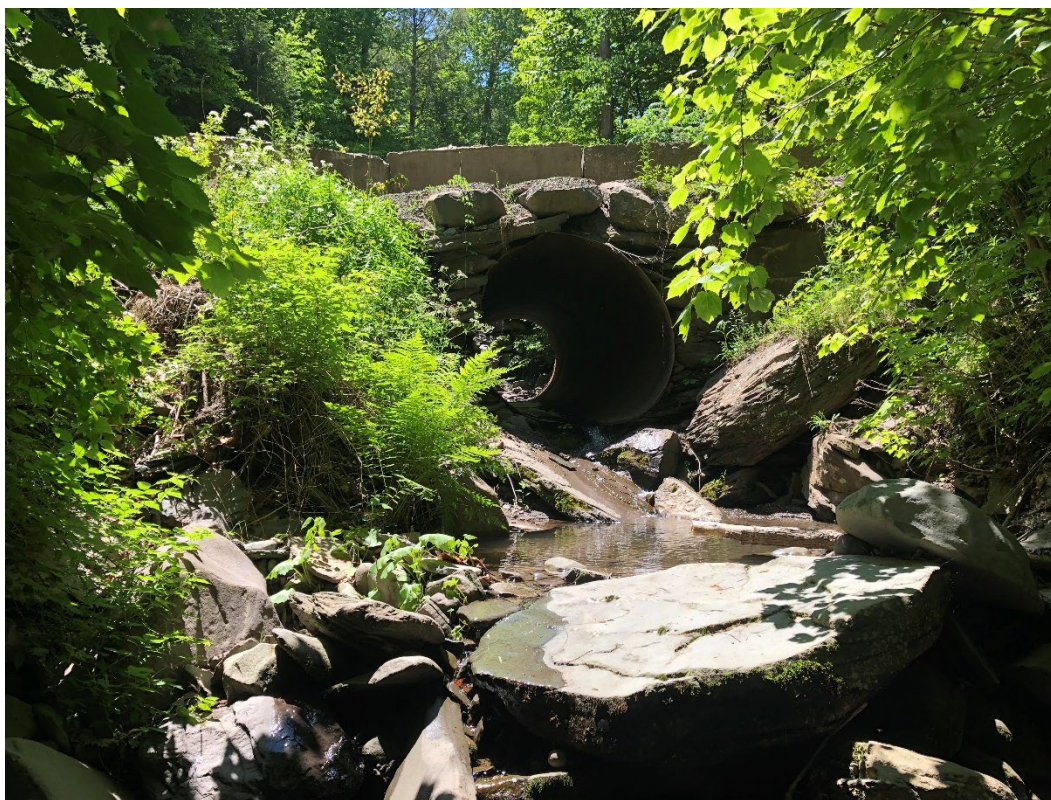
**Figure 4-44: Outlet and tailwater of Station Road culvert at Woodchuck Hollow**

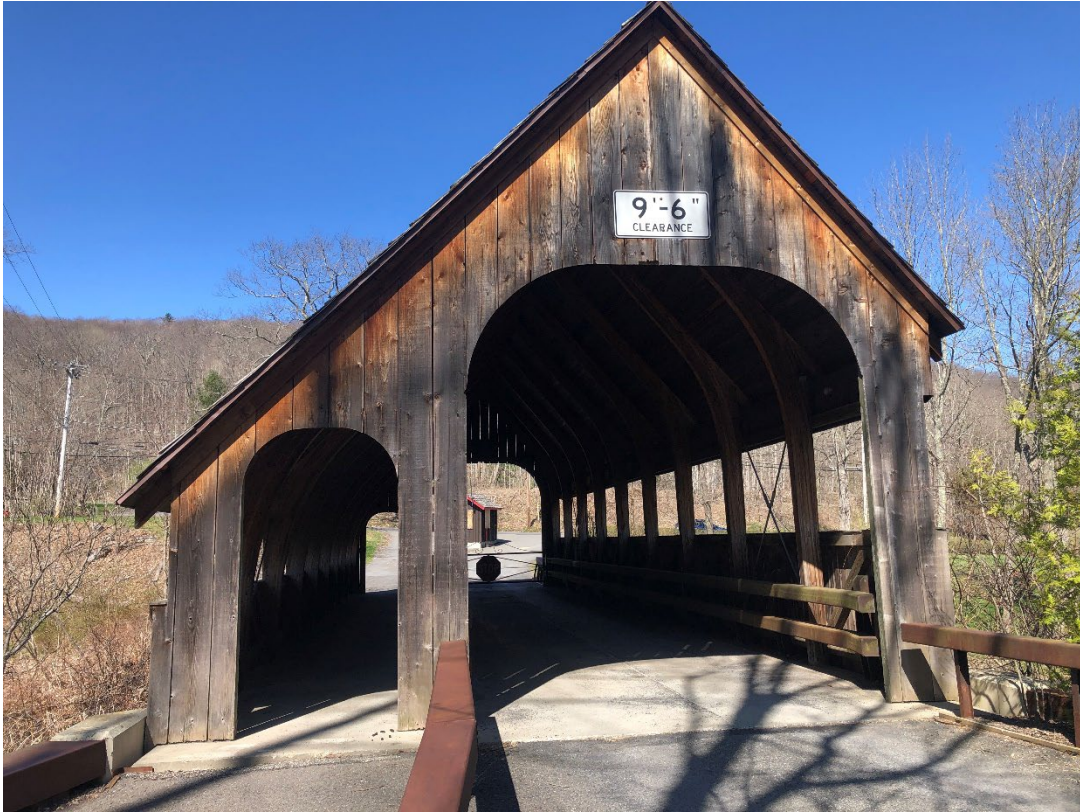
**Figure 4-45: Covered bridge over Birch Creek is the only access to Belleayre Day Use Area.**
